Access Compliance Report

Public Rights-of-Way

(Curb Ramps)

Intersection ID: 10033070	Main Street: NORTH_COMMUNITY_HOUSE_RD	Cross Street: N/A	Location: NW
ADA ID: E0FE4A91E238	Ramp Type: BlendTrans1	Initial Pass/Fail: Pass	Overall Compliance: No
		Severity Score: 0

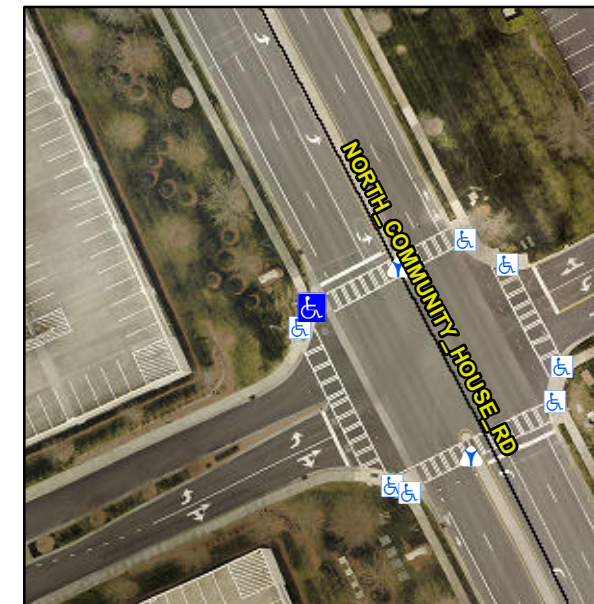
Not Found, R304.2.1

Compliance	Description	Data	Compliance	Description	Data
N/A	Ramp Length (in)	24.0	Yes	BlendTrans Slope (%)	3.4
Yes	Ramp Width (in)	48.0	Yes	BlendTrans XSlope (%)	0.5
N/A	Flare Type LT	Sloped	N/A	Flare Type RT	Sloped
Yes	Flare Slope LT (%)	0.4	Yes	Flare Slope RT (%)	8.5
N/A	Flare Traversable LT?	Yes	N/A	Flare Traversable RT?	Yes
No	Landing Length (in)	51.0	Yes	DWS Provided?	Yes
No	Landing Width (in)	47.0	Yes	DWS Contrast?	Yes
Yes	Landing Slope (%)	1.8	Yes	DWS Length (in)	24.0
Yes	Landing X Slope (%)	0.7	Yes	DWS Full Width?	Yes
N/A	Landing Curb? (Y/N)	Yes	Yes	DWS Offset (in)	0.0
N/A	Shared Landing?	No			
Yes	Gutter Ponding?	No	Yes	Gutter Slope (%)	3.9
Yes	Gutter Lip Ht (in)	0.0	Yes	Gutter X Slope (%)	0.9
N/A	Painted X Walk1?	Yes	N/A	Painted X Walk2?	N/A
	X Walk 1 Direction	To NE		X Walk 2 Direction	N/A
	X Walk 1 Width (in)	110.5		X Walk 2 Width (in)	N/A
	X Walk 1 Slope (%)	3.3		X Walk 2 Slope (%)	N/A
	X Walk 1 X Slope (%)	1.8		X Walk 2 X Slope (%)	N/A

Yes	Ramp inside XWalk1?	Yes	N/A	Ramp inside XWalk2?	N/A
	Road Slope (%)	1.8		Clear Space?	Yes
	Road X Slope (%)	3.3	N/A	Clear Space to XWalk (in)	N/A
Yes	Any Obstructions?	No	Yes	Storm Grate/Utility Hazard?	No
	Obstruction Type			Storm Grate/Utility Type	
		N/A			N/A
			Yes	Surface Condition? (G/P)	Good
			No	Curb Slope (%)	20.8

Remove & Replace Curb Ramp With Two New Directional Ramps or Equivalent.
