# Access Compliance Report

## Public Rights-of-Way

### (Curb Ramps)

Intersection ID: 10038458	Main Street: SOUTHERN_PINE_BV	Cross Street: N/A	Location: S
ADA ID: E0FF42647241	Ramp Type: PerpDiag	Initial Pass/Fail: Fail	Overall Compliance: No
Severity Score: 21.25			
Codes/Mitigation Info/Possible Solution		Field Measurements/Component Compliance

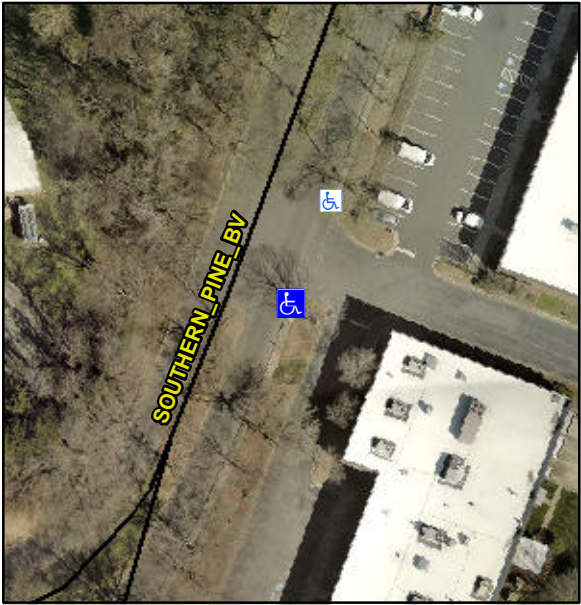
Possible Solutions:	Compliance	Description	Data	Compliance	Description	Data
	Remove & Replace Curb Ramp With Two New Directional Ramps or Equivalent.	N/A	Ramp Length (in)	48.0	Yes	Ramp Slope (%)	5.2
		No	Ramp Width (in)	40.0	No	Ramp XSlope (%)	5.8
		N/A	Flare Type LT	N/A	N/A	Flare Type RT	N/A
		N/A	Flare Slope LT (%)	N/A	N/A	Flare Slope RT (%)	N/A
		N/A	Flare Traversable LT?	N/A	N/A	Flare Traversable RT?	N/A
		N/A	Landing Length (in)	N/A	N/A	DWS Provided?	N/A
		N/A	Landing Width (in)	N/A	N/A	DWS Contrast?	N/A
		N/A	Landing Slope (%)	N/A	N/A	DWS Length (in)	N/A
		N/A	Landing X Slope (%)	N/A	N/A	DWS Full Width?	N/A
		N/A	Landing Curb? (Y/N)	N/A	N/A	DWS Offset (in)	N/A
		N/A	Shared Landing?	N/A			
		N/A	Gutter Ponding?	N/A	N/A	Gutter Slope (%)	N/A
		N/A	Gutter Lip Ht (in)	N/A	N/A	Gutter X Slope (%)	N/A
		N/A	Painted X Walk1?	No	N/A	Painted X Walk2?	No
			X Walk 1 Direction	To N		X Walk 2 Direction	To W

N/A	X Walk 1 Width (in)	N/A	N/A	X Walk 2 Width (in)	N/A
			X Walk 1 Slope (%)	2.0		X Walk 2 Slope (%)	2.0
			X Walk 1 X Slope (%)	2.9		X Walk 2 X Slope (%)	0.0
		N/A	Ramp inside XWalk1?	N/A	N/A	Ramp inside XWalk2?	N/A
<p>Surveyor Notes:</p> <p>N/A</p> <p>PROW/ADA:</p> <p>Not Found, R304.5.1, R304.5.3</p>			Road Slope (%)	0.8	N/A	Clear Space?	N/A
			Road X Slope (%)	0.7	N/A	Clear Space to XWalk (in)	N/A
		N/A	Any Obstructions?	N/A	N/A	Storm Grate/Utility Hazard?	N/A
			Obstruction Type			Storm Grate/Utility Type	
					N/A		N/A
					Yes	Surface Condition? (G/P)	Good

Total Cost: \$ 3200.00
