# Access Compliance Report

## Public Rights-of-Way

### (Curb Ramps)

| Intersection ID: 48058 | Main Street: FERRELL_AV | Cross Street: KEENER_RIDGE_RD | Location: SW |

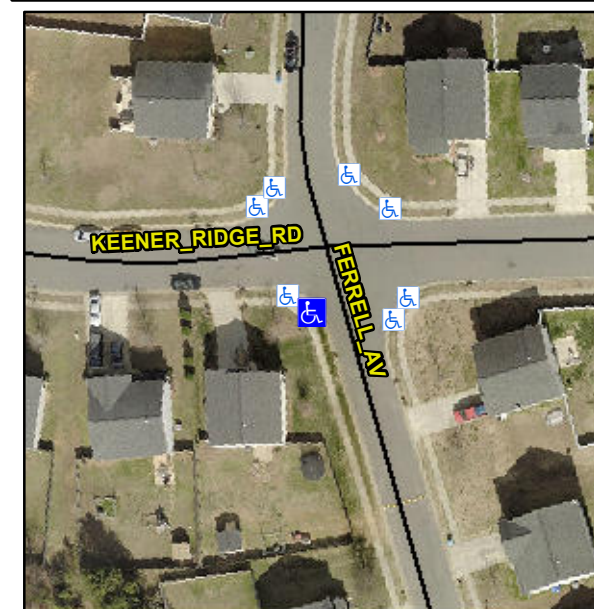
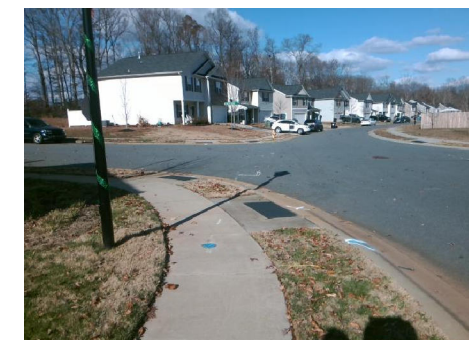
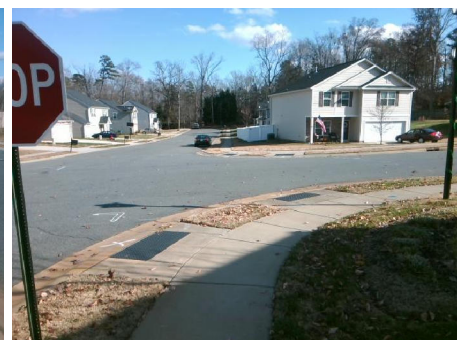
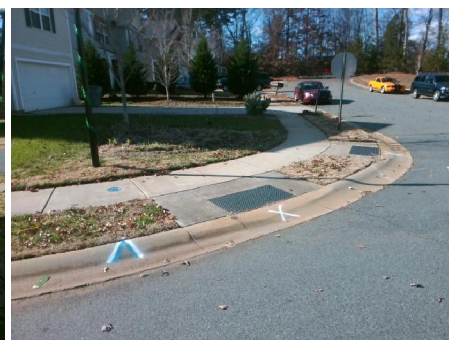
**Not Found, R304.2.1, R304.2.2-Perp,  
R304.3.2-Para, R304.5.4**

| Compliance | Description | Data | Compliance | Description | Data |
|---|---|---|---|---|---|
| No | Landing Length (in) | 47.5 | Yes | DWS Provided? | Yes |
| No | Landing Slope (%) | 3.2 | Yes | DWS Length (in) | 25.0 |
| Yes | Gutter Ponding? | No | No | Gutter Slope (%) | 9.0 |

**Remove & Replace Entire Ramp.  
Remove & Replace Gutter.**
