# Access Compliance Report

## Public Rights-of-Way

### (Curb Ramps)

| Intersection ID: 54269 | Main Street: JOHNSTON_OEHLER_RD | Cross Street: OEHLER_BRIDGE_DR | Location: | N |

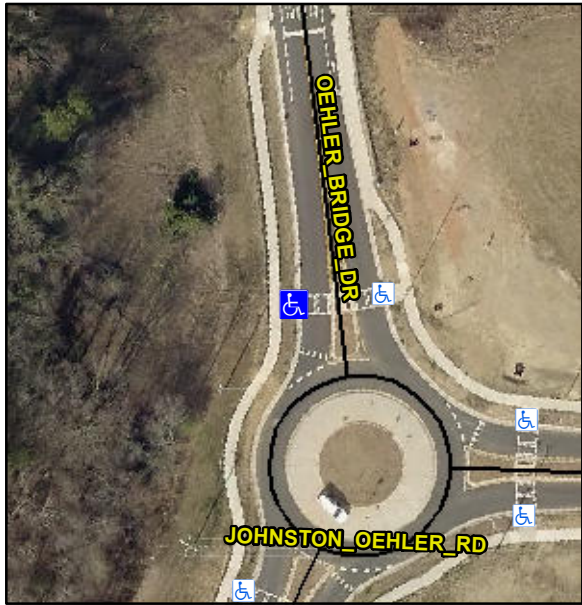
| ADA ID: E104A9D36363 | Ramp Type: Perp | Initial Pass/Fail: Pass | Overall Compliance: No | Severity Score: 5 |

| Codes/Mitigation Info/Possible Solution | | | Field Measurements/Component Compliance | | | | | |
|---|---|---|---|---|---|---|---|---|
| | | | No | Landing Slope (%) | 2.4 | Yes | DWS Length (in) | 24.0 |
| Surveyor Notes: | | No | Landing Curb? (Y/N) | No | Yes | DWS Offset (in) | 0.0 | |
| PROW/ADA: | | Yes | Gutter Ponding? | No | No | Gutter Slope (%) | 7.4 | |

| Codes/Mitigation Info/Possible Solution | | | Field Measurements/Component Compliance | | | | | |
|---|---|---|---|---|---|---|---|---|
| | Remove & Replace Landing. | | N/A | Ramp Length (in) | 96.0 | Yes | Ramp Slope (%) | 7.7 |
| | Remove & Replace Gutter. | | Yes | Ramp Width (in) | 70.0 | Yes | Ramp XSlope (%) | 0.8 |
