# Access Compliance Report

## Public Rights-of-Way

### (Curb Ramps)

| Intersection ID: 43847 | Main Street: BRADSTREET COMMONS WY | Cross Street: ROTHMAN LN | Location: S |

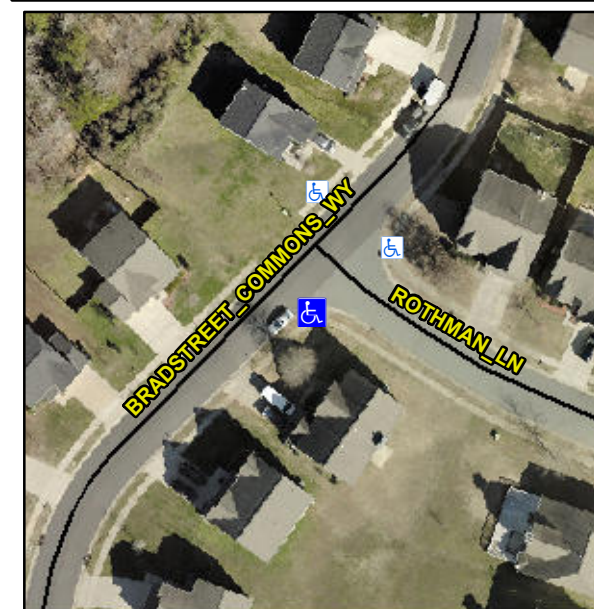
**Not Found, R304.5.3, R304.2.1, R304.2.2-Perp, R304.3.2-Para, R302.7.2, R304.5.4**

| Compliance | Description | Data | Compliance | Description | Data |
|---|---|---|---|---|---|
| Yes | Ramp Width (in) | 48.0 | No | Ramp XSlope (%) | 4.0 |
| No | Landing Length (in) | 47.0 | Yes | DWS Provided? | Yes |
| No | Landing Slope (%) | 2.1 | Yes | DWS Length (in) | 24.0 |
| No | Landing X Slope (%) | 3.3 | Yes | DWS Full Width? | Yes |
| Yes | Gutter Ponding? | No | No | Gutter Slope (%) | 5.8 |
| No | Gutter Lip Ht (in) | 0.5 | No | Gutter X Slope (%) | 3.0 |

**Remove & Replace Curb Ramp With Two New Directional Ramps or Equivalent. Remove & Replace Gutter.**
