# Access Compliance Report

## Public Rights-of-Way

### (Curb Ramps)

Intersection ID: 30018	Main Street: W_MALLARD_CREEK_CHURCH_DR	Cross Street: BERKELEY_PLACE_DR	Location: NW
ADA ID: E1194C04CE04	Ramp Type: Perp	Initial Pass/Fail: Fail	Overall Compliance: No
Severity Score: 37.5			
Codes/Mitigation Info/Possible Solution		Field Measurements/Component Compliance

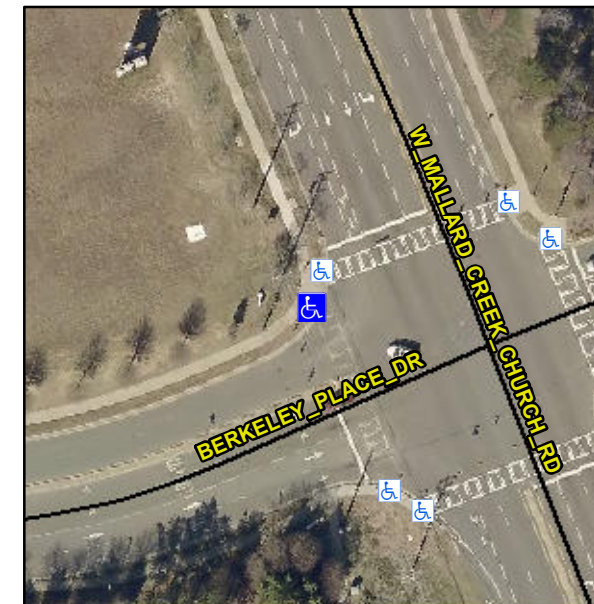
Compliance	Description	Data	Compliance	Description	Data
N/A	Ramp Length (in)	72.0	No	Ramp Slope (%)	20.0
Yes	Ramp Width (in)	48.0	No	Ramp XSlope (%)	6.1
N/A	Flare Type LT	N/A	N/A	Flare Type RT	N/A
N/A	Flare Slope LT (%)	N/A	N/A	Flare Slope RT (%)	N/A
N/A	Flare Traversable LT?	N/A	N/A	Flare Traversable RT?	N/A
N/A	Landing Length (in)	N/A	N/A	DWS Provided?	N/A
N/A	Landing Width (in)	N/A	N/A	DWS Contrast?	N/A
N/A	Landing Slope (%)	N/A	N/A	DWS Length (in)	N/A
N/A	Landing X Slope (%)	N/A	N/A	DWS Full Width?	N/A
N/A	Landing Curb? (Y/N)	N/A	N/A	DWS Offset (in)	N/A
N/A	Shared Landing?	N/A			
N/A	Gutter Ponding?	N/A	N/A	Gutter Slope (%)	N/A
N/A	Gutter Lip Ht (in)	N/A	N/A	Gutter X Slope (%)	N/A
N/A	Painted X Walk1?	Yes	N/A	Painted X Walk2?	N/A
	X Walk 1 Direction	To S		X Walk 2 Direction	N/A
N/A	X Walk 1 Width (in)	112.0	N/A	X Walk 2 Width (in)	N/A
	X Walk 1 Slope (%)	1.0		X Walk 2 Slope (%)	N/A
	X Walk 1 X Slope (%)	6.3		X Walk 2 X Slope (%)	N/A

N/A	Ramp inside XWalk1?	Yes	N/A	Ramp inside XWalk2?	N/A
	Road Slope (%)	N/A	N/A	Clear Space?	N/A
	Road X Slope (%)	N/A	N/A	Clear Space to XWalk (in)	N/A
N/A	Any Obstructions?	N/A	N/A	Storm Grate/Utility Hazard?	N/A
	Obstruction Type			Storm Grate/Utility Type	
		N/A			N/A
		Yes		Surface Condition? (G/P)	Good

Possible Solutions:

**Remove & Replace Entire Ramp.**

**R304.2.2, R304.5.3**
