Access Compliance Report

Public Rights-of-Way

(Curb Ramps)

Intersection ID: 11357	Main Street: W_TRADE_ST	Cross Street: N_IRWIN_AV	Location:	E
ADA ID: E1253579EB35	Ramp Type: Perp	Initial Pass/Fail: Fail	Overall Compliance: No	Severity Score: 12.5
Codes/Mitigation Info/Possible Solution		Field Measurements/Component Compliance

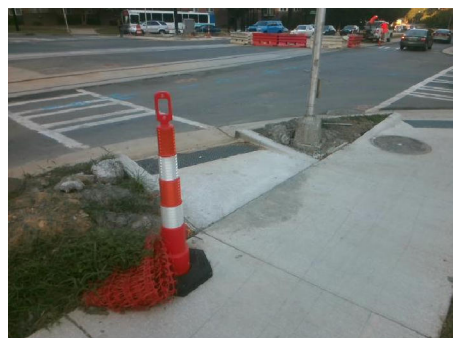
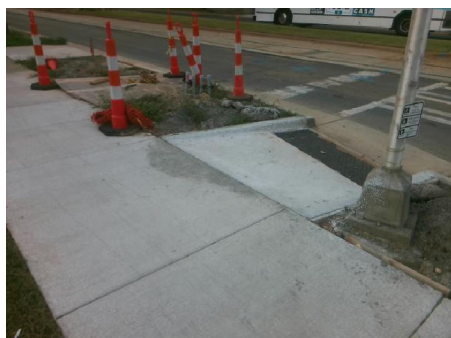
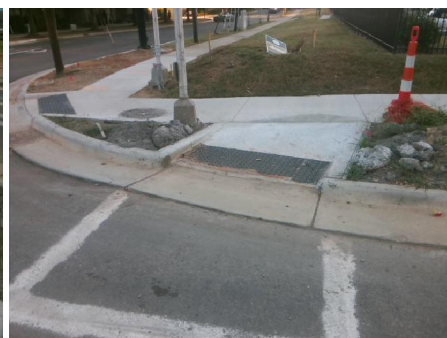
Compliance	Description	Data	Compliance	Description	Data
N/A	Ramp Length (in)	62.0	Yes	Ramp Slope (%)	7.1
Yes	Ramp Width (in)	73.0	No	Ramp XSlope (%)	5.7
N/A	Flare Type LT	N/A	N/A	Flare Type RT	N/A
N/A	Flare Slope LT (%)	N/A	N/A	Flare Slope RT (%)	N/A
N/A	Flare Traversable LT?	N/A	N/A	Flare Traversable RT?	N/A
N/A	Landing Length (in)	N/A	N/A	DWS Provided?	N/A
N/A	Landing Width (in)	N/A	N/A	DWS Contrast?	N/A
N/A	Landing Slope (%)	N/A	N/A	DWS Length (in)	N/A
N/A	Landing X Slope (%)	N/A	N/A	DWS Full Width?	N/A
N/A	Landing Curb? (Y/N)	N/A	N/A	DWS Offset (in)	N/A
N/A	Shared Landing?	N/A			
N/A	Gutter Ponding?	N/A	N/A	Gutter Slope (%)	N/A
N/A	Gutter Lip Ht (in)	N/A	N/A	Gutter X Slope (%)	N/A
N/A	Painted X Walk1?	Yes	N/A	Painted X Walk2?	N/A
	X Walk 1 Direction	To SW		X Walk 2 Direction	N/A
N/A	X Walk 1 Width (in)	75.0	N/A	X Walk 2 Width (in)	N/A
	X Walk 1 Slope (%)	0.6		X Walk 2 Slope (%)	N/A
	X Walk 1 X Slope (%)	5.2		X Walk 2 X Slope (%)	N/A

N/A	Ramp inside XWalk1?	Yes	N/A	Ramp inside XWalk2?	N/A
	Road Slope (%)	N/A	N/A	Clear Space?	N/A
	Road X Slope (%)	N/A	N/A	Clear Space to XWalk (in)	N/A
N/A	Any Obstructions?	N/A	N/A	Storm Grate/Utility Hazard?	N/A
	Obstruction Type			Storm Grate/Utility Type	
		N/A			N/A
		Yes		Surface Condition? (G/P)	Good

Remove & Replace Entire Ramp.

R304.5.3
