# Access Compliance Report

## Public Rights-of-Way

### (Curb Ramps)

Intersection ID: 45096	Main Street: E_9TH_ST	Cross Street: N_DAVIDSON_ST	Location: E
ADA ID: E12BF0A40B5F	Ramp Type: Perp	Initial Pass/Fail: Fail	Overall Compliance: No
Severity Score: 1.25			
Codes/Mitigation Info/Possible Solution		Field Measurements/Component Compliance

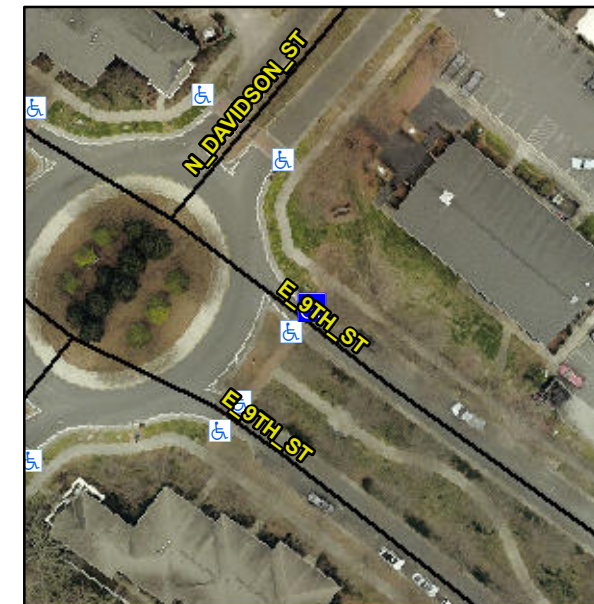
**Not Found, R304.5.3**

Compliance	Description	Data	Compliance	Description	Data
N/A	Ramp Length (in)	157.5	Yes	Ramp Slope (%)	5.7
Yes	Ramp Width (in)	71.0	No	Ramp XSlope (%)	3.3
N/A	Flare Type LT	N/A	N/A	Flare Type RT	N/A
N/A	Flare Slope LT (%)	N/A	N/A	Flare Slope RT (%)	N/A
N/A	Flare Traversable LT?	N/A	N/A	Flare Traversable RT?	N/A
N/A	Landing Length (in)	N/A	N/A	DWS Provided?	N/A
N/A	Landing Width (in)	N/A	N/A	DWS Contrast?	N/A
N/A	Landing Slope (%)	N/A	N/A	DWS Length (in)	N/A
N/A	Landing X Slope (%)	N/A	N/A	DWS Full Width?	N/A
N/A	Landing Curb? (Y/N)	N/A	N/A	DWS Offset (in)	N/A
N/A	Shared Landing?	N/A			
N/A	Gutter Ponding?	N/A	N/A	Gutter Slope (%)	N/A
N/A	Gutter Lip Ht (in)	N/A	N/A	Gutter X Slope (%)	N/A
N/A	Painted X Walk1?	Yes	N/A	Painted X Walk2?	N/A
	X Walk 1 Direction	To SW		X Walk 2 Direction	N/A
N/A	X Walk 1 Width (in)	82.0	N/A	X Walk 2 Width (in)	N/A
	X Walk 1 Slope (%)	0.0		X Walk 2 Slope (%)	N/A
	X Walk 1 X Slope (%)	2.4		X Walk 2 X Slope (%)	N/A

N/A	Ramp inside XWalk1?	Yes	N/A	Ramp inside XWalk2?	N/A
	Road Slope (%)	N/A	N/A	Clear Space?	N/A
	Road X Slope (%)	N/A	N/A	Clear Space to XWalk (in)	N/A
N/A	Any Obstructions?	N/A	N/A	Storm Grate/Utility Hazard?	N/A
	Obstruction Type			Storm Grate/Utility Type	
		N/A			N/A
		Yes		Surface Condition? (G/P)	Good

**Remove & Replace Entire Ramp.**

Total Cost: \$ 1850.00
