Access Compliance Report

Public Rights-of-Way

(Curb Ramps)

Intersection ID: 6586	Main Street: ARVIN_DR	Cross Street: ATLAS_DR	Location: NW
ADA ID: E12BF986B530	Ramp Type: Perp	Initial Pass/Fail: Fail	Overall Compliance: No
		Severity Score: 8.75

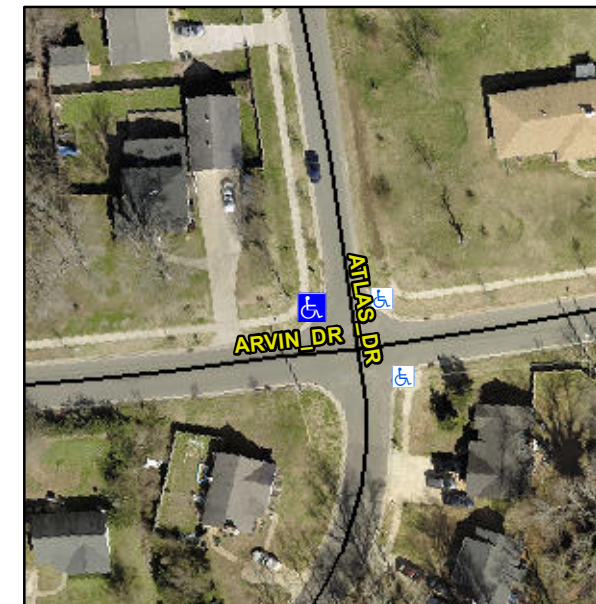
Not Found, R304.5.1

Compliance	Description	Data	Compliance	Description	Data
N/A	Ramp Length (in)	72.0	Yes	Ramp Slope (%)	7.5
No	Ramp Width (in)	47.0	Yes	Ramp XSlope (%)	2.0
N/A	Flare Type LT	N/A	N/A	Flare Type RT	N/A
N/A	Flare Slope LT (%)	N/A	N/A	Flare Slope RT (%)	N/A
N/A	Flare Traversable LT?	N/A	N/A	Flare Traversable RT?	N/A
N/A	Landing Length (in)	N/A	N/A	DWS Provided?	N/A
N/A	Landing Width (in)	N/A	N/A	DWS Contrast?	N/A
N/A	Landing Slope (%)	N/A	N/A	DWS Length (in)	N/A
N/A	Landing X Slope (%)	N/A	N/A	DWS Full Width?	N/A
N/A	Landing Curb? (Y/N)	N/A	N/A	DWS Offset (in)	N/A
N/A	Shared Landing?	N/A			
N/A	Gutter Ponding?	N/A	N/A	Gutter Slope (%)	N/A
N/A	Gutter Lip Ht (in)	N/A	N/A	Gutter X Slope (%)	N/A
N/A	Painted X Walk1?	No	N/A	Painted X Walk2?	N/A
	X Walk 1 Direction	To E		X Walk 2 Direction	N/A
N/A	X Walk 1 Width (in)	N/A	N/A	X Walk 2 Width (in)	N/A
	X Walk 1 Slope (%)	1.6		X Walk 2 Slope (%)	N/A
	X Walk 1 X Slope (%)	3.0		X Walk 2 X Slope (%)	N/A

Remove & Replace Entire Ramp.

Total Cost: \$ 1850.00
