Access Compliance Report Public Rights-of-Way (Curb Ramps)

Intersection ID: 10823 Main Street: MURDOCK_RD Cross Street: THE_PLAZA Location: E

ADA ID: E12DB27E842B Ramp Type: BlendTrans1 Initial Pass/Fail: Fail Overall Compliance: No Severity Score: 8.75

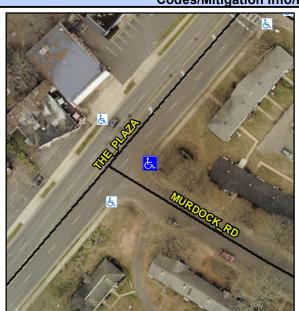
Not Found, R304.5.1

Compliance Description Data Compliance Description Data Yes BlendTrans Slope (%) N/A Ramp Length (in) 66.0 4.1 Yes No Ramp Width (in) 37.0 BlendTrans XSlope (%) 0.3 N/A N/A Flare Type LT N/A Flare Type RT N/A N/A Flare Slope LT (%) N/A N/A Flare Slope RT (%) N/A N/A Flare Traversable LT? N/A N/A Flare Traversable RT? N/A N/A N/A N/A **DWS Provided?** N/A Landing Length (in) N/A Landing Width (in) N/A N/A **DWS Contrast?** N/A N/A N/A Landing Slope (%) N/A DWS Length (in) N/A N/A Landing X Slope (%) N/A N/A DWS Full Width? N/A N/A Landing Curb? (Y/N) N/A N/A DWS Offset (in) N/A N/A N/A Shared Landing? N/A **Gutter Ponding?** N/A N/A Gutter Slope (%) N/A N/A Gutter Lip Ht (in) N/A N/A Gutter X Slope (%) N/A N/A Painted X Walk1? No N/A Painted X Walk2? No X Walk 1 Direction To NW X Walk 2 Direction To SW N/A X Walk 1 Width (in) X Walk 2 Width (in) N/A X Walk 1 Slope (%) 3.7 X Walk 2 Slope (%) 0.4 X Walk 1 X Slope (%) 0.6 X Walk 2 X Slope (%) 4.0 N/A N/A Ramp inside XWalk2? N/A Ramp inside XWalk1? N/A Road Slope (%) 0.3 Clear Space? N/A Road X Slope (%) N/A Clear Space to XWalk (in) N/A 0.2 N/A N/A N/A Any Obstructions? Storm Grate/Utility Hazard? N/A **Obstruction Type** Storm Grate/Utility Type N/A N/A Yes Surface Condition? (G/P) Good

No

Curb Slope (%)

15.0

THE PLAZA None MURDOCK RD StopSign Possible Solutions:

Remove & Replace Curb Ramp With Two New Directional Ramps or Equivalent.

Total Cost: \$ 3200.00
