## Access Compliance Report Public Rights-of-Way (Curb Ramps)

Intersection ID: 10026308Main Street: FAIRVIEW\_RDCross Street: N/ALocation:SWADA ID: E1332E09B0D8Ramp Type: PerpDiagInitial Pass/Fail: FailOverall Compliance: NoSeverity Score: 33.75

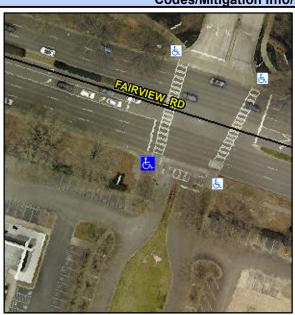
Not Found, R304.5.1, R304.2.2

Field Measurements/Component Compliance					
Comp	liance Description	Data	Comp	liance Description	Data
N/A	Ramp Length (in)	39.0	No	Ramp Slope (%)	13.6
No	Ramp Width (in)	42.0	Yes	Ramp XSlope (%)	1.5
N/A	Flare Type LT	N/A	N/A	Flare Type RT	N/A
N/A	Flare Slope LT (%)	N/A	N/A	Flare Slope RT (%)	N/A
N/A	Flare Traversable LT?	N/A	N/A	Flare Traversable RT?	N/A
N/A	Landing Length (in)	N/A	N/A	DWS Provided?	N/A
N/A	Landing Width (in)	N/A	N/A	DWS Contrast?	N/A
N/A	Landing Slope (%)	N/A	N/A	DWS Length (in)	N/A
N/A	Landing X Slope (%)	N/A	N/A	DWS Full Width?	N/A
N/A	Landing Curb? (Y/N)	N/A	N/A	DWS Offset (in)	N/A
N/A	Shared Landing?	N/A			
N/A	Gutter Ponding?	N/A	N/A	Gutter Slope (%)	N/A
N/A	Gutter Lip Ht (in)	N/A	N/A	Gutter X Slope (%)	N/A
N/A	Painted X Walk1?	Yes	N/A	Painted X Walk2?	Yes
	X Walk 1 Direction	To SE		X Walk 2 Direction	To NE
N/A	X Walk 1 Width (in)	102.0	N/A	X Walk 2 Width (in)	109.0
	X Walk 1 Slope (%)	0.8		X Walk 2 Slope (%)	1.4

X Walk 1 X Slope (%)	0.1		X Walk 2 X Slope (%)	1.3
N/A	Ramp inside XWalk1?	Yes	N/A	Ramp inside XWalk2?	Yes
	Road Slope (%)	1.7	N/A	Clear Space?	N/A
	Road X Slope (%)	1.6	N/A	Clear Space to XWalk (in)	N/A
N/A	Any Obstructions?	N/A	N/A	Storm Grate/Utility Hazard?	N/A
	Obstruction Type			Storm Grate/Utility Type	
		N/A			N/A
			Yes	Surface Condition? (G/P)	Good
A SARON

Remove & Replace Curb Ramp With Two New Directional Ramps or Equivalent.
