Access Compliance Report

Public Rights-of-Way

(Curb Ramps)

Intersection ID: 10427	Main Street: CALLAHAN_ST	Cross Street: POLK_ST	Location: W
ADA ID: E1365FDC26F3	Ramp Type: Perp	Initial Pass/Fail: Fail	Overall Compliance: No
Codes/Mitigation Info/Possible Solution		Field Measurements/Component Compliance	
Severity Score: 21.25

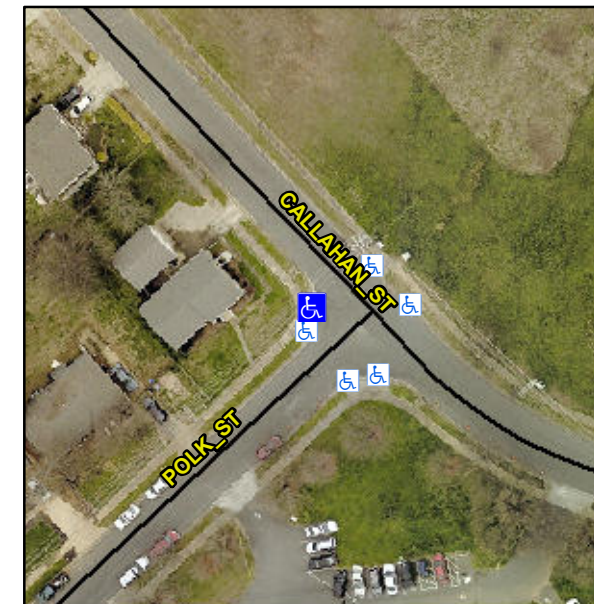
Not Found, R304.5.1, R304.5.3

Compliance	Description	Data	Compliance	Description	Data
N/A	Ramp Length (in)	59.0	Yes	Ramp Slope (%)	7.3
No	Ramp Width (in)	42.0	No	Ramp XSlope (%)	5.8
N/A	Flare Type LT	N/A	N/A	Flare Type RT	N/A
N/A	Flare Slope LT (%)	N/A	N/A	Flare Slope RT (%)	N/A
N/A	Flare Traversable LT?	N/A	N/A	Flare Traversable RT?	N/A
N/A	Landing Length (in)	N/A	N/A	DWS Provided?	N/A
N/A	Landing Width (in)	N/A	N/A	DWS Contrast?	N/A
N/A	Landing Slope (%)	N/A	N/A	DWS Length (in)	N/A
N/A	Landing X Slope (%)	N/A	N/A	DWS Full Width?	N/A
N/A	Landing Curb? (Y/N)	N/A	N/A	DWS Offset (in)	N/A
N/A	Shared Landing?	N/A			
N/A	Gutter Ponding?	N/A	N/A	Gutter Slope (%)	N/A
N/A	Gutter Lip Ht (in)	2.0	N/A	Gutter X Slope (%)	N/A
N/A	Painted X Walk1?	No	N/A	Painted X Walk2?	N/A
	X Walk 1 Direction	To NE		X Walk 2 Direction	N/A
N/A	X Walk 1 Width (in)	N/A	N/A	X Walk 2 Width (in)	N/A
	X Walk 1 Slope (%)	4.7		X Walk 2 Slope (%)	N/A
	X Walk 1 X Slope (%)	2.1		X Walk 2 X Slope (%)	N/A

Possible Solutions:

Remove & Replace Entire Ramp.
