Access Compliance Report

Public Rights-of-Way

(Curb Ramps)

Intersection ID: 12684	Main Street: S_BREVARD_ST	Cross Street: E_4TH_ST	Location: W
ADA ID: E14A5FCD91D1	Ramp Type: Perp	Initial Pass/Fail: Fail	Overall Compliance: No
			Severity Score: 47.5
Codes/Mitigation Info/Possible Solution		Field Measurements/Component Compliance

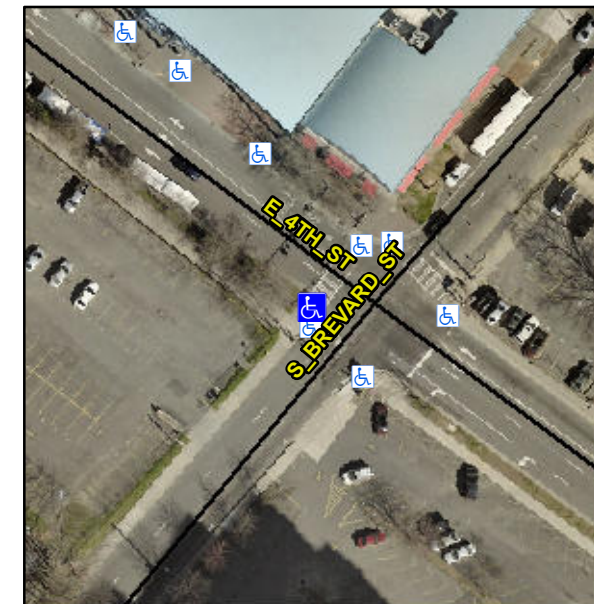
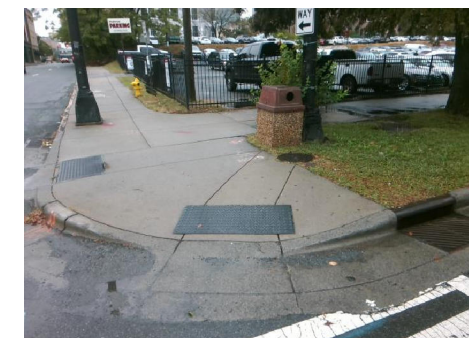
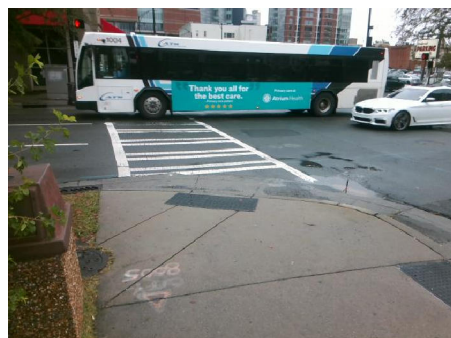
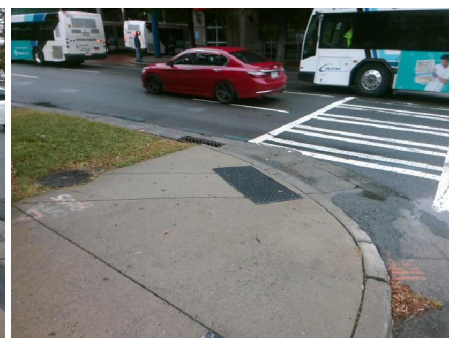
Not Found, R304.5.1, R304.2.2

Compliance	Description	Data	Compliance	Description	Data
N/A	Ramp Length (in)	90.0	No	Ramp Slope (%)	8.8
No	Ramp Width (in)	30.0	Yes	Ramp XSlope (%)	0.5
N/A	Flare Type LT	N/A	N/A	Flare Type RT	N/A
N/A	Flare Slope LT (%)	N/A	N/A	Flare Slope RT (%)	N/A
N/A	Flare Traversable LT?	N/A	N/A	Flare Traversable RT?	N/A
N/A	Landing Length (in)	N/A	N/A	DWS Provided?	N/A
N/A	Landing Width (in)	N/A	N/A	DWS Contrast?	N/A
N/A	Landing Slope (%)	N/A	N/A	DWS Length (in)	N/A
N/A	Landing X Slope (%)	N/A	N/A	DWS Full Width?	N/A
N/A	Landing Curb? (Y/N)	N/A	N/A	DWS Offset (in)	N/A
N/A	Shared Landing?	N/A			
N/A	Gutter Ponding?	N/A	N/A	Gutter Slope (%)	N/A
N/A	Gutter Lip Ht (in)	N/A	N/A	Gutter X Slope (%)	N/A
N/A	Painted X Walk1?	Yes	N/A	Painted X Walk2?	N/A
	X Walk 1 Direction	To NE		X Walk 2 Direction	N/A
N/A	X Walk 1 Width (in)	111.0	N/A	X Walk 2 Width (in)	N/A
	X Walk 1 Slope (%)	1.2		X Walk 2 Slope (%)	N/A
	X Walk 1 X Slope (%)	0.5		X Walk 2 X Slope (%)	N/A

N/A	Ramp inside XWalk1?	Yes	N/A	Ramp inside XWalk2?	N/A
	Road Slope (%)	N/A	N/A	Clear Space?	N/A
	Road X Slope (%)	N/A	N/A	Clear Space to XWalk (in)	N/A
N/A	Any Obstructions?	N/A	N/A	Storm Grate/Utility Hazard?	N/A
	Obstruction Type			Storm Grate/Utility Type	
		N/A			N/A
			Yes	Surface Condition? (G/P)	Good

Remove & Replace Entire Ramp.
