# Access Compliance Report

## Public Rights-of-Way (Curb Ramps)

Intersection ID: 6107	Main Street: HAMPTON_CHURCH_RD	Cross Street: N_TRYON_ST	Location: NE
ADA ID: E15B6BB63E91	Ramp Type: Directional1	Initial Pass/Fail: Fail	Overall Compliance: No
		Severity Score: 1.25

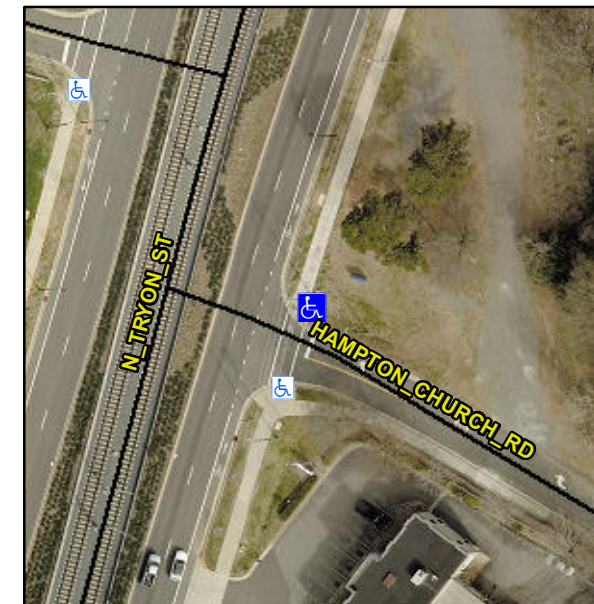
Compliance	Description	Data	Compliance	Description	Data
N/A	Ramp Length (in)	88.0	N/A	Grade Break?	N/A
Yes	Ramp Width (in)	96.0	N/A	Grade Break Slope (%)	0.0
Yes	Ramp Slope (%)	4.5	N/A	Grade Break XSlope (%)	0.0
No	Ramp XSlope (%)	3.2			
N/A	Flare Type LT	N/A	N/A	Flare Type RT	N/A
N/A	Flare Slope LT (%)	N/A	N/A	Flare Slope RT (%)	0.0
N/A	Flare Traversable LT?	N/A	N/A	Flare Traversable RT?	N/A
N/A	Landing Length (in)	0.0	N/A	DWS Provided?	N/A
N/A	Landing Width (in)	0.0	N/A	DWS Contrast?	N/A
N/A	Landing Slope (%)	0.0	N/A	DWS Length (in)	N/A
N/A	Landing X Slope (%)	0.0	N/A	DWS Full Width?	N/A
N/A	Landing Curb? (Y/N)	N/A	N/A	DWS Offset LT (in)	N/A
N/A	Shared Landing?	N/A	N/A	DWS Offset RT (in)	N/A
N/A	Gutter Ponding?	0.0	N/A	Gutter Slope (%)	N/A
N/A	Gutter Lip Ht (in)	0.0	N/A	Gutter X Slope (%)	N/A
N/A	Painted X Walk1?	Yes		Road Slope (%)	2.2
	X Walk 1 Direction	To S		Road X Slope (%)	3.2
	X Walk 1 Width (in)	115.0		Clear Space?	N/A

X Walk 1 Slope (%)	2.2	N/A	Clear Space to XWalk (in)	N/A
	X Walk 1 X Slope (%)	3.2	N/A	Storm Grate/Utility Hazard?	N/A
N/A	Ramp inside XWalk1?	Yes		Storm Grate/Utility Type	
N/A	Any Obstructions?	N/A			N/A
	Obstruction Type		Yes	Surface Condition? (G/P)	Good
			N/A	Curb Slope (%)	5.0

**Remove & Replace Entire Ramp.**
