Access Compliance Report

Public Rights-of-Way

(Curb Ramps)

Intersection ID: 25709	Main Street: CHARTER_OAK_LN	Cross Street: JOHNSTON_RD	Location: NW
ADA ID: E161E256218B	Ramp Type: Perp	Initial Pass/Fail: Fail	Overall Compliance: No
Severity Score: 12.5			
Codes/Mitigation Info/Possible Solution		Field Measurements/Component Compliance

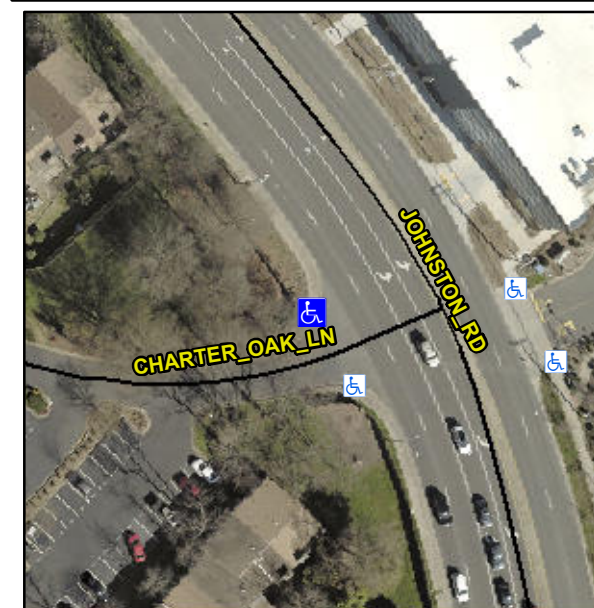
Compliance	Description	Data	Compliance	Description	Data
N/A	Ramp Length (in)	60.0	Yes	Ramp Slope (%)	7.6
Yes	Ramp Width (in)	48.0	No	Ramp XSlope (%)	5.9
N/A	Flare Type LT	N/A	N/A	Flare Type RT	N/A
N/A	Flare Slope LT (%)	N/A	N/A	Flare Slope RT (%)	N/A
N/A	Flare Traversable LT?	N/A	N/A	Flare Traversable RT?	N/A
N/A	Landing Length (in)	N/A	N/A	DWS Provided?	N/A
N/A	Landing Width (in)	N/A	N/A	DWS Contrast?	N/A
N/A	Landing Slope (%)	N/A	N/A	DWS Length (in)	N/A
N/A	Landing X Slope (%)	N/A	N/A	DWS Full Width?	N/A
N/A	Landing Curb? (Y/N)	N/A	N/A	DWS Offset (in)	N/A
N/A	Shared Landing?	N/A			
N/A	Gutter Ponding?	N/A	N/A	Gutter Slope (%)	N/A
N/A	Gutter Lip Ht (in)	N/A	N/A	Gutter X Slope (%)	N/A
N/A	Painted X Walk1?	No	N/A	Painted X Walk2?	N/A
	X Walk 1 Direction	To SE		X Walk 2 Direction	N/A
N/A	X Walk 1 Width (in)	N/A	N/A	X Walk 2 Width (in)	N/A
	X Walk 1 Slope (%)	1.6		X Walk 2 Slope (%)	N/A
	X Walk 1 X Slope (%)	6.7		X Walk 2 X Slope (%)	N/A

N/A	Ramp inside XWalk1?	N/A	N/A	Ramp inside XWalk2?	N/A
	Road Slope (%)	N/A	N/A	Clear Space?	N/A
	Road X Slope (%)	N/A	N/A	Clear Space to XWalk (in)	N/A
N/A	Any Obstructions?	N/A	N/A	Storm Grate/Utility Hazard?	N/A
	Obstruction Type			Storm Grate/Utility Type	
		N/A			N/A
		Yes		Surface Condition? (G/P)	Good

Possible Solutions:

Remove & Replace Entire Ramp.

Not Found, R304.5.3
