Access Compliance Report

Public Rights-of-Way

(Curb Ramps)

Intersection ID: 25199	Main Street: DONNEGAL_FARM_RD	Cross Street: BRIDLE_BROOK_WY	Location:	N
ADA ID: E1627A9FB2D6	Ramp Type: Perp	Initial Pass/Fail: Fail	Overall Compliance: No	Severity Score: 25
Codes/Mitigation Info/Possible Solution		Field Measurements/Component Compliance

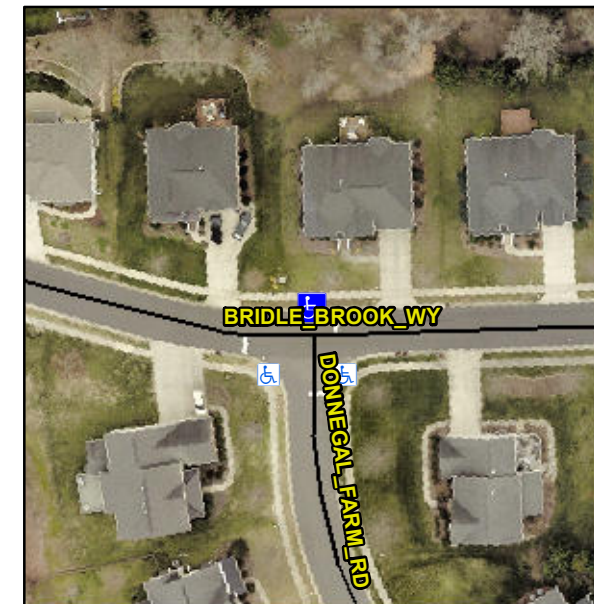
Not Found, R304.2.2, R304.5.3

Compliance	Description	Data	Compliance	Description	Data
N/A	Ramp Length (in)	47.0	No	Ramp Slope (%)	9.9
Yes	Ramp Width (in)	48.0	No	Ramp XSlope (%)	5.8
N/A	Flare Type LT	N/A	N/A	Flare Type RT	N/A
N/A	Flare Slope LT (%)	N/A	N/A	Flare Slope RT (%)	N/A
N/A	Flare Traversable LT?	N/A	N/A	Flare Traversable RT?	N/A
N/A	Landing Length (in)	N/A	N/A	DWS Provided?	N/A
N/A	Landing Width (in)	N/A	N/A	DWS Contrast?	N/A
N/A	Landing Slope (%)	N/A	N/A	DWS Length (in)	N/A
N/A	Landing X Slope (%)	N/A	N/A	DWS Full Width?	N/A
N/A	Landing Curb? (Y/N)	N/A	N/A	DWS Offset (in)	N/A
N/A	Shared Landing?	N/A			
N/A	Gutter Ponding?	N/A	N/A	Gutter Slope (%)	N/A
N/A	Gutter Lip Ht (in)	N/A	N/A	Gutter X Slope (%)	N/A
N/A	Painted X Walk1?	No	N/A	Painted X Walk2?	N/A
	X Walk 1 Direction	To SE		X Walk 2 Direction	N/A
N/A	X Walk 1 Width (in)	N/A	N/A	X Walk 2 Width (in)	N/A
	X Walk 1 Slope (%)	4.3		X Walk 2 Slope (%)	N/A
	X Walk 1 X Slope (%)	6.1		X Walk 2 X Slope (%)	N/A

N/A	Ramp inside XWalk1?	N/A	N/A	Ramp inside XWalk2?	N/A
	Road Slope (%)	N/A	N/A	Clear Space?	N/A
	Road X Slope (%)	N/A	N/A	Clear Space to XWalk (in)	N/A
N/A	Any Obstructions?	N/A	N/A	Storm Grate/Utility Hazard?	N/A
	Obstruction Type			Storm Grate/Utility Type	
		N/A			N/A
			Yes	Surface Condition? (G/P)	Good

Remove & Replace Entire Ramp.
