Access Compliance Report

Public Rights-of-Way

(Curb Ramps)

Intersection ID: 7885	Main Street: MONTANA_DR	Cross Street: BEATTIES_FORD_RD	Location: NW
ADA ID: E165E4FA47C9	Ramp Type: Perp	Initial Pass/Fail: Fail	Overall Compliance: No
Severity Score: 10			
Codes/Mitigation Info/Possible Solution		Field Measurements/Component Compliance

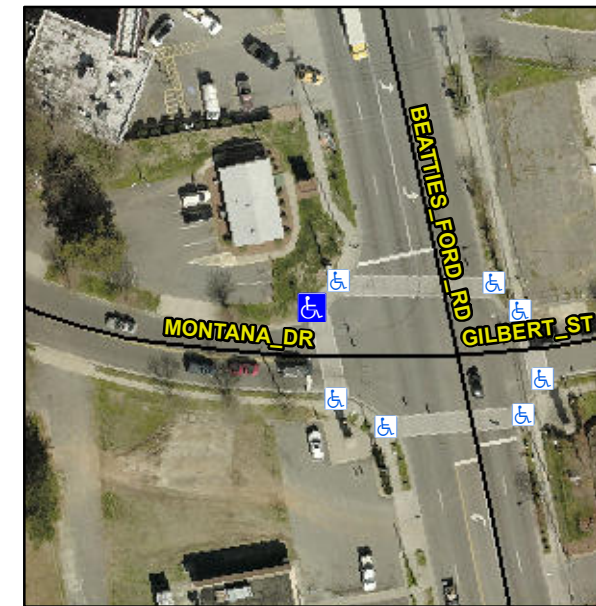
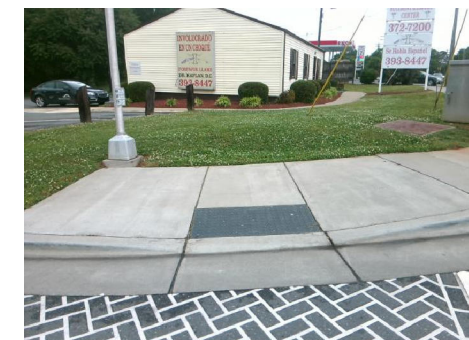
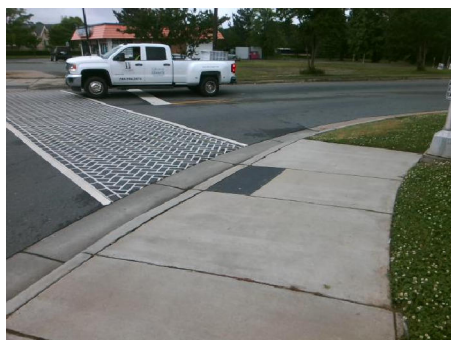
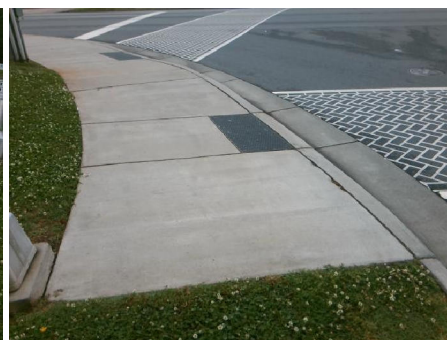
Not Found, R304.5.1, R304.5.3

Compliance	Description	Data	Compliance	Description	Data
N/A	Ramp Length (in)	83.5	Yes	Ramp Slope (%)	7.8
No	Ramp Width (in)	44.0	No	Ramp XSlope (%)	4.9
N/A	Flare Type LT	N/A	N/A	Flare Type RT	N/A
N/A	Flare Slope LT (%)	N/A	N/A	Flare Slope RT (%)	N/A
N/A	Flare Traversable LT?	N/A	N/A	Flare Traversable RT?	N/A
N/A	Landing Length (in)	N/A	N/A	DWS Provided?	N/A
N/A	Landing Width (in)	N/A	N/A	DWS Contrast?	N/A
N/A	Landing Slope (%)	N/A	N/A	DWS Length (in)	N/A
N/A	Landing X Slope (%)	N/A	N/A	DWS Full Width?	N/A
N/A	Landing Curb? (Y/N)	N/A	N/A	DWS Offset (in)	N/A
N/A	Shared Landing?	N/A			
N/A	Gutter Ponding?	N/A	N/A	Gutter Slope (%)	N/A
N/A	Gutter Lip Ht (in)	N/A	N/A	Gutter X Slope (%)	N/A
N/A	Painted X Walk1?	Yes	N/A	Painted X Walk2?	N/A
	X Walk 1 Direction	To S		X Walk 2 Direction	N/A
N/A	X Walk 1 Width (in)	120.5	N/A	X Walk 2 Width (in)	N/A
	X Walk 1 Slope (%)	1.1		X Walk 2 Slope (%)	N/A
	X Walk 1 X Slope (%)	3.4		X Walk 2 X Slope (%)	N/A

N/A	Ramp inside XWalk1?	Yes	N/A	Ramp inside XWalk2?	N/A
	Road Slope (%)	N/A	N/A	Clear Space?	N/A
	Road X Slope (%)	N/A	N/A	Clear Space to XWalk (in)	N/A
N/A	Any Obstructions?	N/A	N/A	Storm Grate/Utility Hazard?	N/A
	Obstruction Type			Storm Grate/Utility Type	
		N/A			N/A
		Yes		Surface Condition? (G/P)	Good

Remove & Replace Entire Ramp.

Total Cost: \$ 1850.00
