Access Compliance Report

Public Rights-of-Way

(Curb Ramps)

Intersection ID: 11601	Main Street: N_POPLAR_ST	Cross Street: SETTLERS_LN	Location:	N
ADA ID: E167313BB8AB	Ramp Type: Directional2	Initial Pass/Fail: Fail	Overall Compliance: No	Severity Score: 25
Codes/Mitigation Info/Possible Solution		Field Measurements/Component Compliance

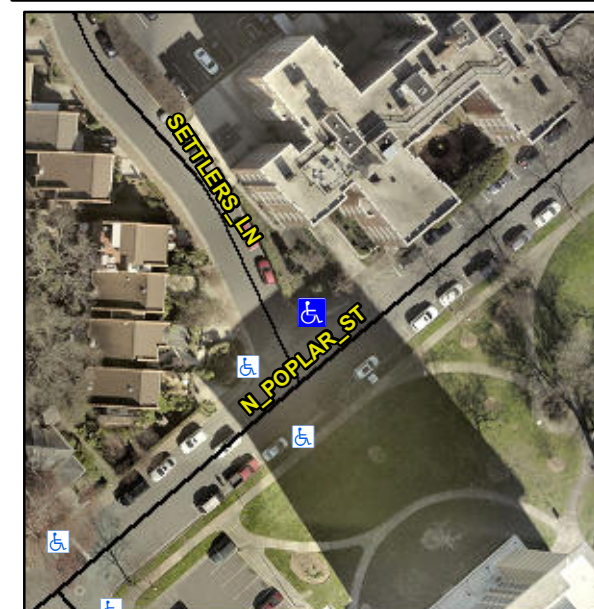
R304.2.2, R304.5.3

Compliance	Description	Data	Compliance	Description	Data
N/A	Ramp Length (in)	45.0	N/A	Grade Break?	N/A
Yes	Ramp Width (in)	70.0	N/A	Grade Break Slope (%)	0.0
No	Ramp Slope (%)	9.7	N/A	Grade Break XSlope (%)	0.0
No	Ramp XSlope (%)	5.4			
N/A	Flare Type LT	N/A	N/A	Flare Type RT	N/A
N/A	Flare Slope LT (%)	N/A	N/A	Flare Slope RT (%)	0.0
N/A	Flare Traversable LT?	N/A	N/A	Flare Traversable RT?	N/A
N/A	Landing Length (in)	0.0	N/A	DWS Provided?	N/A
N/A	Landing Width (in)	0.0	N/A	DWS Contrast?	N/A
N/A	Landing Slope (%)	0.0	N/A	DWS Length (in)	N/A
N/A	Landing X Slope (%)	0.0	N/A	DWS Full Width?	N/A
N/A	Landing Curb? (Y/N)	N/A	N/A	DWS Offset LT (in)	N/A
N/A	Shared Landing?	N/A	N/A	DWS Offset RT (in)	N/A
N/A	Gutter Ponding?	0.0	N/A	Gutter Slope (%)	N/A
N/A	Gutter Lip Ht (in)	0.0	N/A	Gutter X Slope (%)	N/A
N/A	Painted X Walk1?	No		Road Slope (%)	0.2
	X Walk 1 Direction	To SW		Road X Slope (%)	0.4
	X Walk 1 Width (in)	N/A		Clear Space?	N/A

X Walk 1 Slope (%)	0.2	N/A	Clear Space to XWalk (in)	N/A
	X Walk 1 X Slope (%)	0.4	N/A	Storm Grate/Utility Hazard?	N/A
N/A	Ramp inside XWalk1?	N/A		Storm Grate/Utility Type	
N/A	Any Obstructions?	N/A			N/A
	Obstruction Type		Yes	Surface Condition? (G/P)	Good
			N/A	Curb Slope (%)	16.0

Possible Solutions:

Remove & Replace Entire Ramp.
