# Access Compliance Report

## Public Rights-of-Way

### (Curb Ramps)

Intersection ID: 15599	Main Street: COLVILLE_RD	Cross Street: EASTOVER_RD	Location: NW
ADA ID: E16973EDA403	Ramp Type: PerpDiag	Initial Pass/Fail: Fail	Overall Compliance: No
Codes/Mitigation Info/Possible Solution		Field Measurements/Component Compliance

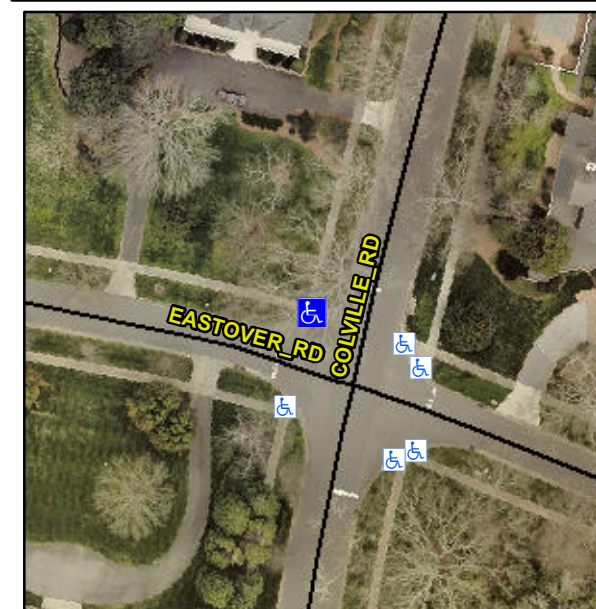
**Not Found, R304.5.3**

Compliance	Description	Data	Compliance	Description	Data
N/A	Ramp Length (in)	58.0	Yes	Ramp Slope (%)	6.5
Yes	Ramp Width (in)	48.0	No	Ramp XSlope (%)	3.5
N/A	Flare Type LT	N/A	N/A	Flare Type RT	N/A
N/A	Flare Slope LT (%)	N/A	N/A	Flare Slope RT (%)	N/A
N/A	Flare Traversable LT?	N/A	N/A	Flare Traversable RT?	N/A
N/A	Landing Length (in)	N/A	N/A	DWS Provided?	N/A
N/A	Landing Width (in)	N/A	N/A	DWS Contrast?	N/A
N/A	Landing Slope (%)	N/A	N/A	DWS Length (in)	N/A
N/A	Landing X Slope (%)	N/A	N/A	DWS Full Width?	N/A
N/A	Landing Curb? (Y/N)	N/A	N/A	DWS Offset (in)	N/A
N/A	Shared Landing?	N/A			
N/A	Gutter Ponding?	N/A	N/A	Gutter Slope (%)	N/A
N/A	Gutter Lip Ht (in)	N/A	N/A	Gutter X Slope (%)	N/A
N/A	Painted X Walk1?	No	N/A	Painted X Walk2?	No
	X Walk 1 Direction	To SW		X Walk 2 Direction	To SE
N/A	X Walk 1 Width (in)	N/A	N/A	X Walk 2 Width (in)	N/A
	X Walk 1 Slope (%)	0.6		X Walk 2 Slope (%)	1.5
	X Walk 1 X Slope (%)	3.0		X Walk 2 X Slope (%)	0.4

N/A	Ramp inside XWalk1?	N/A	N/A	Ramp inside XWalk2?	N/A
	Road Slope (%)	1.3	N/A	Clear Space?	N/A
	Road X Slope (%)	3.0	N/A	Clear Space to XWalk (in)	N/A
N/A	Any Obstructions?	N/A	N/A	Storm Grate/Utility Hazard?	N/A
	Obstruction Type			Storm Grate/Utility Type	
		N/A			N/A
			Yes	Surface Condition? (G/P)	Good

**Remove & Replace Curb Ramp With Two New Directional Ramps or Equivalent.**

Total Cost: \$ 3200.00
