Access Compliance Report Public Rights-of-Way (Curb Ramps)

Intersection ID: 5972 Main Street: DAWYCK_LN Cross Street: SUNSTONE_DR Location: NW ADA ID: E17298D068D6 Ramp Type: Directional1 Initial Pass/Fail: Fail **Overall Compliance: No Severity Score:** 8.75

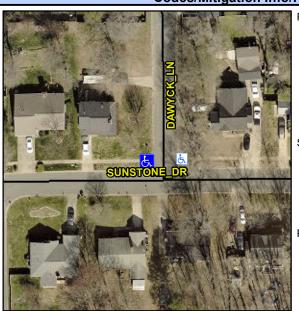
on obsidic delation			ricia incusurements/component compnance					
Possible Solutions:			Compliance Description		Data	ta Compliance Description		Data
Remove & Replace Entire	Ram	ıp.	N/A	Ramp Length (in)	51.0	N/A	Grade Break?	N/A
			No	Ramp Width (in)	46.0	N/A	Grade Break Slope (%)	0.0
			Yes	Ramp Slope (%)	5.4	N/A	Grade Break XSlope (%)	0.0
			Yes	Ramp XSlope (%)	1.2			
			N/A	Flare Type LT	N/A	N/A	Flare Type RT	N/A
			N/A	Flare Slope LT (%)	N/A	N/A	Flare Slope RT (%)	0.0
Surveyor Notes:			N/A	Flare Traversable LT?	N/A	N/A	Flare Traversable RT?	N/A
TREE STUMP OBS			N/A	Landing Length (in)	0.0	N/A	DWS Provided?	N/A
<u> </u>			N/A	Landing Width (in)	0.0	N/A	DWS Contrast?	N/A
			N/A	Landing Slope (%)	0.0	N/A	DWS Length (in)	N/A
			N/A	Landing X Slope (%)	0.0	N/A	DWS Full Width?	N/A
PROW/ADA:			N/A	Landing Curb? (Y/N)	N/A	N/A	DWS Offset LT (in)	N/A
R304.5.1			N/A	Shared Landing?	N/A	N/A	DWS Offset RT (in)	N/A

N/A	Gutter Ponding?	0.0	N/A	Gutter Slope (%)	N/A
			N/A	Gutter Lip Ht (in)	0.0	N/A	Gutter X Slope (%)	N/A
X.			N/A	Painted X Walk1?	No		Road Slope (%)	3.7
				X Walk 1 Direction	To E		Road X Slope (%)	3.9
				X Walk 1 Width (in)	N/A	l	Clear Space?	N/A
				X Walk 1 Slope (%)	3.7	N/A	Clear Space to XWalk (in)	N/A
				X Walk 1 X Slope (%)	3.9	N/A	Storm Grate/Utility Hazard?	N/A
			N/A	Ramp inside XWalk1?	N/A		Storm Grate/Utility Type	
			N/A	Any Obstructions?	N/A			N/A
Total Cost:	\$	1600.00		Obstruction Type		Yes	Surface Condition? (G/P)	Good
