# Access Compliance Report

## Public Rights-of-Way

### (Curb Ramps)

Intersection ID: 43986	Main Street: CANYON_CREEK_LN	Cross Street: HOSKINS_RIDGE_LN	Location: SE
ADA ID: E172AEAC34F7	Ramp Type: PerpDiag	Initial Pass/Fail: Fail	Overall Compliance: No
Severity Score: 10			
Codes/Mitigation Info/Possible Solution		Field Measurements/Component Compliance

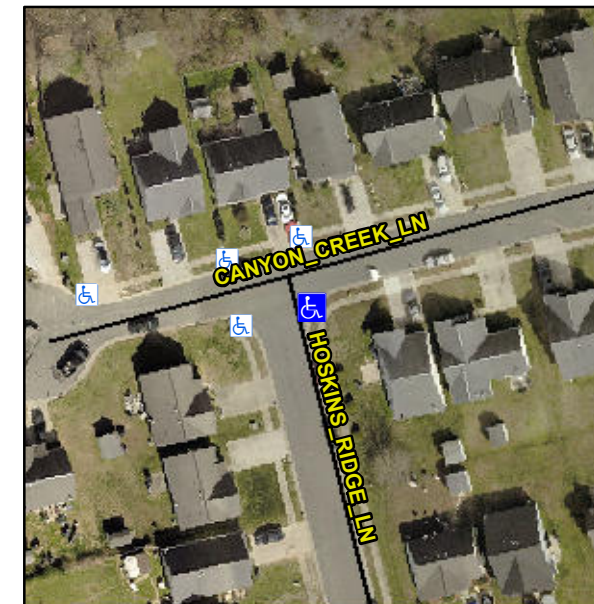
**R304.5.1, R304.5.3**

Compliance	Description	Data	Compliance	Description	Data
N/A	Ramp Length (in)	95.5	Yes	Ramp Slope (%)	7.5
No	Ramp Width (in)	38.0	No	Ramp XSlope (%)	2.6
N/A	Flare Type LT	N/A	N/A	Flare Type RT	N/A
N/A	Flare Slope LT (%)	N/A	N/A	Flare Slope RT (%)	N/A
N/A	Flare Traversable LT?	N/A	N/A	Flare Traversable RT?	N/A
N/A	Landing Length (in)	N/A	N/A	DWS Provided?	N/A
N/A	Landing Width (in)	N/A	N/A	DWS Contrast?	N/A
N/A	Landing Slope (%)	N/A	N/A	DWS Length (in)	N/A
N/A	Landing X Slope (%)	N/A	N/A	DWS Full Width?	N/A
N/A	Landing Curb? (Y/N)	N/A	N/A	DWS Offset (in)	N/A
N/A	Shared Landing?	N/A			
N/A	Gutter Ponding?	N/A	N/A	Gutter Slope (%)	N/A
N/A	Gutter Lip Ht (in)	N/A	N/A	Gutter X Slope (%)	N/A
N/A	Painted X Walk1?	No	N/A	Painted X Walk2?	No
	X Walk 1 Direction	To N		X Walk 2 Direction	To W
N/A	X Walk 1 Width (in)	N/A	N/A	X Walk 2 Width (in)	N/A
	X Walk 1 Slope (%)	2.8		X Walk 2 Slope (%)	2.9
	X Walk 1 X Slope (%)	1.4		X Walk 2 X Slope (%)	1.5

N/A	Ramp inside XWalk1?	N/A	N/A	Ramp inside XWalk2?	N/A
	Road Slope (%)	2.1	N/A	Clear Space?	N/A
	Road X Slope (%)	1.2	N/A	Clear Space to XWalk (in)	N/A
N/A	Any Obstructions?	N/A	N/A	Storm Grate/Utility Hazard?	N/A
	Obstruction Type			Storm Grate/Utility Type	
		N/A			N/A
			Yes	Surface Condition? (G/P)	Good

**Remove & Replace Curb Ramp With Two New Directional Ramps or Equivalent.**
