Access Compliance Report

Public Rights-of-Way

(Curb Ramps)

Intersection ID: N/A	Main Street: MILLENNIUM_AV	Cross Street: CITY_PARK_DR	Location: SE
ADA ID: E17E7C3DF399	Ramp Type: MedianPerp	Initial Pass/Fail: Fail	Overall Compliance: No
Severity Score: 1.25			
Codes/Mitigation Info/Possible Solution		Field Measurements/Component Compliance

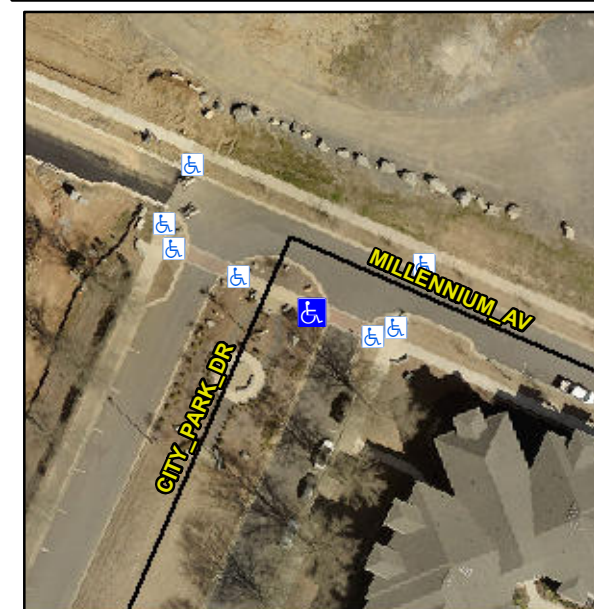
Not Found, R304.5.3

Compliance	Description	Data	Compliance	Description	Data
N/A	Ramp Length (in)	156.0	Yes	Ramp Slope (%)	6.8
Yes	Ramp Width (in)	70.0	No	Ramp XSlope (%)	2.8
N/A	Flare Type LT	N/A	N/A	Flare Type RT	N/A
N/A	Flare Slope LT (%)	N/A	N/A	Flare Slope RT (%)	N/A
N/A	Flare Traversable LT?	N/A	N/A	Flare Traversable RT?	N/A
N/A	Landing Length (in)	N/A	N/A	DWS Provided?	N/A
N/A	Landing Width (in)	N/A	N/A	DWS Contrast?	N/A
N/A	Landing Slope (%)	N/A	N/A	DWS Length (in)	N/A
N/A	Landing X Slope (%)	N/A	N/A	DWS Full Width?	N/A
N/A	Landing Curb? (Y/N)	N/A	N/A	DWS Offset (in)	N/A
N/A	Shared Landing?	N/A			
N/A	Gutter Ponding?	N/A	N/A	Gutter Slope (%)	N/A
N/A	Gutter Lip Ht (in)	N/A	N/A	Gutter X Slope (%)	N/A
N/A	Painted X Walk1?	Yes	N/A	Painted X Walk2?	N/A
	X Walk 1 Direction	To SE		X Walk 2 Direction	N/A
N/A	X Walk 1 Width (in)	84.0	N/A	X Walk 2 Width (in)	N/A
	X Walk 1 Slope (%)	0.4		X Walk 2 Slope (%)	N/A
	X Walk 1 X Slope (%)	3.0		X Walk 2 X Slope (%)	N/A

N/A	Ramp inside XWalk1?	Yes	N/A	Ramp inside XWalk2?	N/A
	Road Slope (%)	N/A	N/A	Clear Space?	N/A
	Road X Slope (%)	N/A	N/A	Clear Space to XWalk (in)	N/A
N/A	Any Obstructions?	N/A	N/A	Storm Grate/Utility Hazard?	N/A
	Obstruction Type			Storm Grate/Utility Type	
		N/A			N/A
		Yes		Surface Condition? (G/P)	Good

Remove & Replace Entire Ramp.
