# Access Compliance Report

## Public Rights-of-Way

### (Curb Ramps)

Intersection ID: 10014544	Main Street: BROOKSIDE_LN	Cross Street: N/A	Location: NE
ADA ID: E18216E52B8D	Ramp Type: PerpDiag	Initial Pass/Fail: Fail	Overall Compliance: No
			Severity Score: 33.75

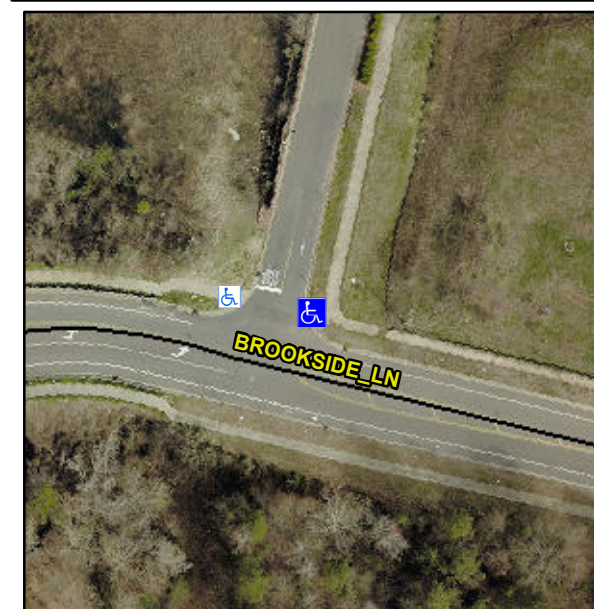
Compliance	Description	Data	Compliance	Description	Data
N/A	Ramp Length (in)	103.5	Yes	Ramp Slope (%)	7.1
No	Ramp Width (in)	40.5	No	Ramp XSlope (%)	7.1
N/A	Flare Type LT	N/A	N/A	Flare Type RT	N/A
N/A	Flare Slope LT (%)	N/A	N/A	Flare Slope RT (%)	N/A
N/A	Flare Traversable LT?	N/A	N/A	Flare Traversable RT?	N/A
N/A	Landing Length (in)	N/A	N/A	DWS Provided?	N/A
N/A	Landing Width (in)	N/A	N/A	DWS Contrast?	N/A
N/A	Landing Slope (%)	N/A	N/A	DWS Length (in)	N/A
N/A	Landing X Slope (%)	N/A	N/A	DWS Full Width?	N/A
N/A	Landing Curb? (Y/N)	N/A	N/A	DWS Offset (in)	N/A
N/A	Shared Landing?	N/A			
N/A	Gutter Ponding?	N/A	N/A	Gutter Slope (%)	N/A
N/A	Gutter Lip Ht (in)	N/A	N/A	Gutter X Slope (%)	N/A
N/A	Painted X Walk1?	No	N/A	Painted X Walk2?	No
	X Walk 1 Direction	To S		X Walk 2 Direction	To W
N/A	X Walk 1 Width (in)	N/A	N/A	X Walk 2 Width (in)	N/A
	X Walk 1 Slope (%)	3.4		X Walk 2 Slope (%)	6.5
	X Walk 1 X Slope (%)	6.5		X Walk 2 X Slope (%)	2.7

N/A	Ramp inside XWalk1?	N/A	N/A	Ramp inside XWalk2?	N/A
	Road Slope (%)	3.1	N/A	Clear Space?	N/A
	Road X Slope (%)	6.3	N/A	Clear Space to XWalk (in)	N/A
N/A	Any Obstructions?	N/A	N/A	Storm Grate/Utility Hazard?	N/A
	Obstruction Type			Storm Grate/Utility Type	
		N/A			N/A
			Yes	Surface Condition? (G/P)	Good

**Remove & Replace Curb Ramp With Two New Directional Ramps or Equivalent.**

**R304.5.1, R304.5.3**
