| Intersection ID: 12099 | Main Street: KENNON_ST | Cross Street: THOMAS_AV | Location: | NW |
| ADA ID: E18D72E8B661 | Ramp Type: Perp | Initial Pass/Fail: Fail | Overall Compliance: No | Severity Score: 12.5 |

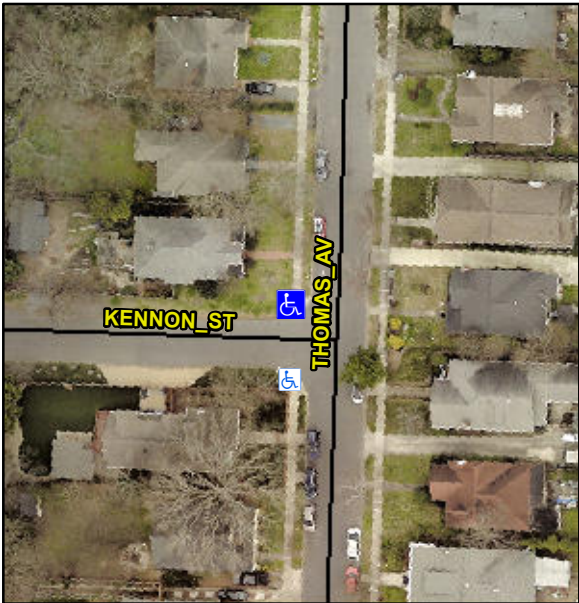
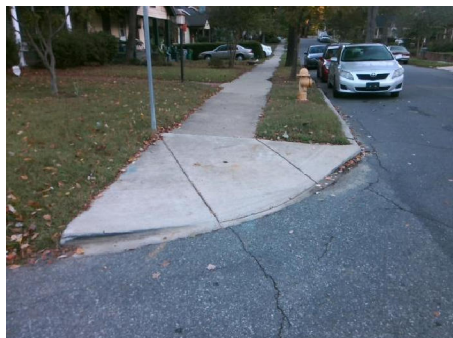
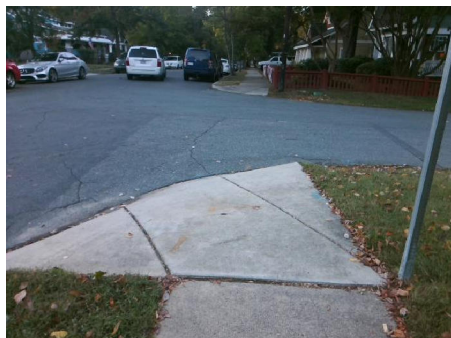
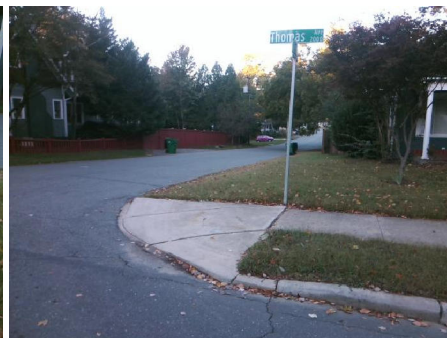
| Codes/Mitigation Info/Possible Solution | | | Field Measurements/Component Compliance | | | | | |
|---|---|--|---|---|---|---|---|---|
| | | | <b>N/A</b> | Ramp Length (in) | <b>63.5</b> | <b>No</b> | Ramp Slope (%) | <b>8.7</b> |
| | | | <b>Yes</b> | Ramp Width (in) | <b>52.5</b> | <b>Yes</b> | Ramp XSlope (%) | <b>0.3</b> |

| Codes/Mitigation Info/Possible Solution | | | Field Measurements/Component Compliance | | | | | |
|---|---|--|---|---|---|---|---|---|
| | Possible Solutions: | | <b>Remove &amp; Replace Entire Ramp.</b> | | | | | |
| | PROW/ADA: | | <b>R304.2.2</b> | | | | | |
