# Access Compliance Report

## Public Rights-of-Way

### (Curb Ramps)

Intersection ID: 23825	Main Street: LOBLOLLY_LN	Cross Street: LONGLEAF_DR	Location: SE
ADA ID: E18FBB00E5AD	Ramp Type: Directional1	Initial Pass/Fail: Fail	Overall Compliance: No
Severity Score: 13.75			
Codes/Mitigation Info/Possible Solution		Field Measurements/Component Compliance

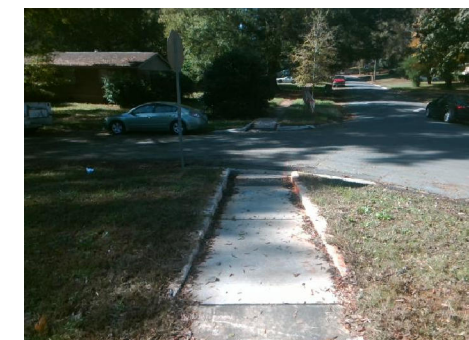
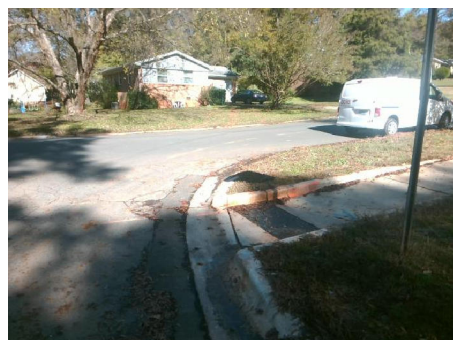
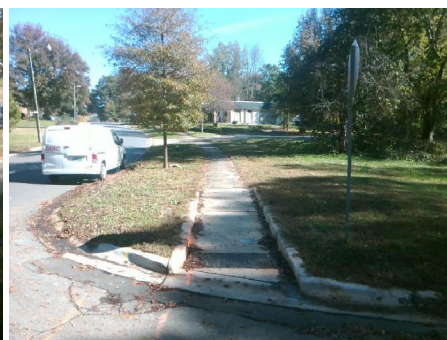
Compliance	Description	Data	Compliance	Description	Data
N/A	Ramp Length (in)	117.0	N/A	Grade Break?	N/A
Yes	Ramp Width (in)	56.0	N/A	Grade Break Slope (%)	0.0
No	Ramp Slope (%)	9.4	N/A	Grade Break XSlope (%)	0.0
No	Ramp XSlope (%)	4.3			
N/A	Flare Type LT	N/A	N/A	Flare Type RT	N/A
N/A	Flare Slope LT (%)	N/A	N/A	Flare Slope RT (%)	0.0
N/A	Flare Traversable LT?	N/A	N/A	Flare Traversable RT?	N/A
N/A	Landing Length (in)	0.0	N/A	DWS Provided?	N/A
N/A	Landing Width (in)	0.0	N/A	DWS Contrast?	N/A
N/A	Landing Slope (%)	0.0	N/A	DWS Length (in)	N/A
N/A	Landing X Slope (%)	0.0	N/A	DWS Full Width?	N/A
N/A	Landing Curb? (Y/N)	N/A	N/A	DWS Offset LT (in)	N/A
N/A	Shared Landing?	N/A	N/A	DWS Offset RT (in)	N/A
N/A	Gutter Ponding?	0.0	N/A	Gutter Slope (%)	N/A
N/A	Gutter Lip Ht (in)	0.0	N/A	Gutter X Slope (%)	N/A
N/A	Painted X Walk1?	No		Road Slope (%)	1.1
	X Walk 1 Direction	To W		Road X Slope (%)	4.4
	X Walk 1 Width (in)	N/A		Clear Space?	N/A

X Walk 1 Slope (%)	1.1	N/A	Clear Space to XWalk (in)	N/A
	X Walk 1 X Slope (%)	4.4	N/A	Storm Grate/Utility Hazard?	N/A
N/A	Ramp inside XWalk1?	N/A		Storm Grate/Utility Type	
N/A	Any Obstructions?	N/A			N/A
	Obstruction Type		Yes	Surface Condition? (G/P)	Good
			N/A	Curb Slope (%)	13.0

**Remove & Replace Entire Ramp.**

**R304.2.2, R304.5.3**
