Access Compliance Report Public Rights-of-Way (Curb Ramps)

Intersection ID: 15246 Main Street: HEFLIN_ST **Cross Street: MCVAY_ST** Location: N **Overall Compliance: No** ADA ID: E197842786BA Ramp Type: Directional1 Initial Pass/Fail: Fail **Severity Score:** 1.25

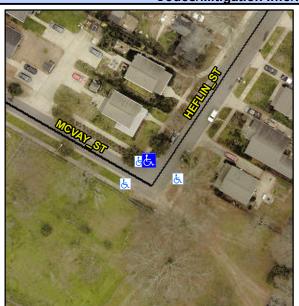
Field Measurements/Component Compliance								
Compliance Description		Data	Comp	liance Description	Data			
N/A	Ramp Length (in)	65.0	N/A	Grade Break?	N/A			
Yes	Ramp Width (in)	59.0	N/A	Grade Break Slope (%)	0.0			
Yes	Ramp Slope (%)	6.8	N/A Grade Break XSlope (%)		0.0			
No	Ramp XSlope (%)	3.4						
N/A	Flare Type LT	N/A	N/A	Flare Type RT	N/A			
N/A	Flare Slope LT (%)	N/A	N/A	Flare Slope RT (%)	0.0			
N/A	Flare Traversable LT?	N/A	N/A	Flare Traversable RT?	N/A			
N/A	Landing Length (in)	0.0	N/A	DWS Provided?	N/A			
N/A	Landing Width (in)	0.0	N/A	DWS Contrast?	N/A			
N/A	Landing Slope (%)	0.0	N/A	DWS Length (in)	N/A			
N/A	Landing X Slope (%)	0.0	N/A	DWS Full Width?	N/A			
N/A	Landing Curb? (Y/N)	N/A	N/A	DWS Offset LT (in)	N/A			
N/A	Shared Landing?	N/A	N/A	DWS Offset RT (in)	N/A			
N/A	Gutter Ponding?	0.0	N/A	Gutter Slope (%)	N/A			
N/A	Gutter Lip Ht (in)	0.0	N/A	Gutter X Slope (%)	N/A			
N/A	Painted X Walk1?	No		Road Slope (%)	1.8

X Walk 1 Direction	То Е		Road X Slope (%)	1.0			
	X Walk 1 Width (in)	N/A		Clear Space?	N/A			
	X Walk 1 Slope (%)	1.8	N/A	Clear Space to XWalk (in)	N/A			
	X Walk 1 X Slope (%)	1.0	N/A	Storm Grate/Utility Hazard?	N/A			
N/A	Ramp inside XWalk1?	N/A		Storm Grate/Utility Type				
N/A	Any Obstructions?	N/A			N/A			
	Obstruction Type		Yes	Surface Condition? (G/P)	Good			
		N/A	N/A	Curb Slope (%)	14.9

V	Possible Solutions:
A CONTRACTOR OF THE PARTY OF TH	Remove & Replace Entire Ramp.
1	
1	
	Surveyor Notes:
	N/A
	N/A
ř	
-	
	PROW/ADA:
S. W. S.	R304.5.3
- Contract	
6 2.

Total Cost:	\$ 1600.00
