# Access Compliance Report

## Public Rights-of-Way (Curb Ramps)

| Intersection ID: N/A | Main Street: BEREWICK_TOWN_CENTRE | Cross Street: N/A | Location: SE |
| ADA ID: E19B63AC93AB | Ramp Type: BlendTrans1 | Initial Pass/Fail: Pass | Overall Compliance: No |

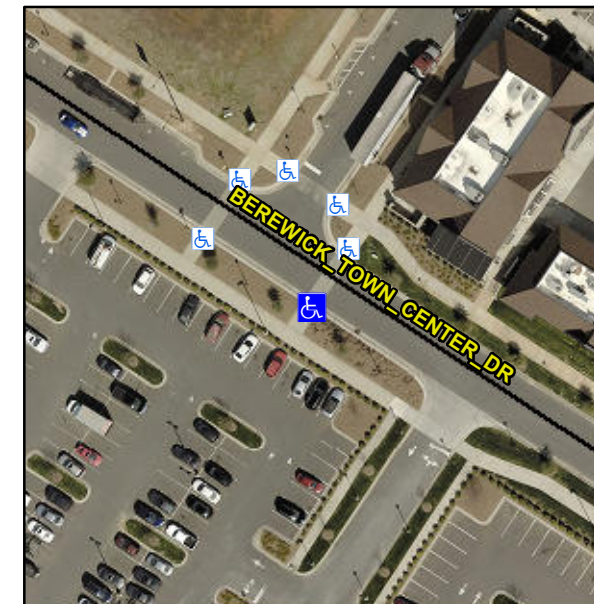
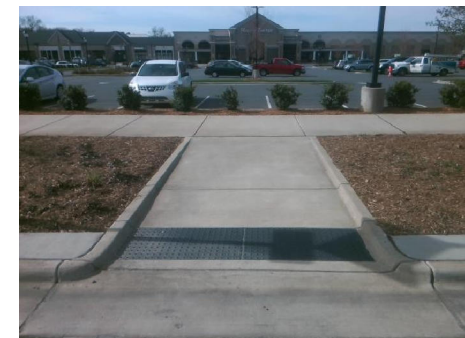
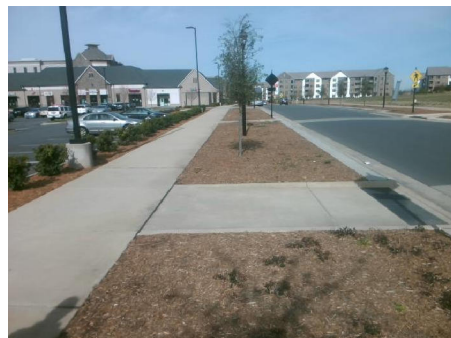
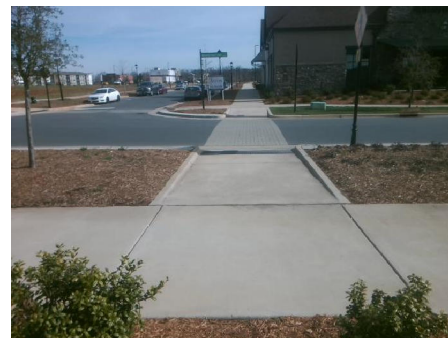
**XWALK PAVERS**

**Not Found, R305.2**

| Compliance | Description | Data | Compliance | Description | Data |
|---|---|---|---|---|---|
| N/A | Landing Curb? (Y/N) | No | No | DWS Offset (in) | 6.0 |
| | | | No | Curb Slope (%) | 22.4 |

**Remove & Replace Curb Ramp With Two New Directional Ramps or Equivalent.**

Total Cost: \$ 3200.00
