# Access Compliance Report

## Public Rights-of-Way

### (Curb Ramps)

| Intersection ID: 46344 | Main Street: BENNETT_NEELY_LN | Cross Street: STREAM_BANK_DR | Location: SE |

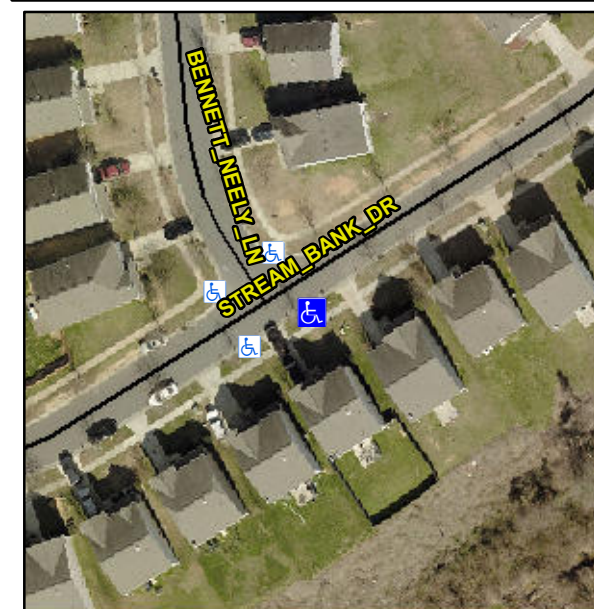
| ADA ID: E1A111AC2587 | Ramp Type: Perp | Initial Pass/Fail: Pass | Overall Compliance: No |

| Severity Score: 10.25 | | | |

**Not Found, R304.5.3, R304.2.1,  
R304.2.2-Perp, R304.3.2-Para, R305**

| Compliance | Description | Data | Compliance | Description | Data |
|---|---|---|---|---|---|
| Yes | Ramp Width (in) | 48.0 | No | Ramp XSlope (%) | 2.6 |
| No | Landing Length (in) | 47.0 | No | DWS Provided? | No |
| No | Landing Slope (%) | 2.2 | N/A | DWS Length (in) | N/A |
| No | Landing X Slope (%) | 2.8 | N/A | DWS Full Width? | No |
| Yes | Gutter Lip Ht (in) | 0.0 | No | Gutter X Slope (%) | 2.6 |

**Remove & Replace Entire Ramp.  
Remove & Replace Gutter.**

Total Cost: \$ 2600.00
