# Access Compliance Report

## Public Rights-of-Way

### (Curb Ramps)

Intersection ID: 10270	Main Street: FONTANA_AV	Cross Street: SPRING_ST	Location: SE
ADA ID: E1A43196E5EE	Ramp Type: Perp	Initial Pass/Fail: Fail	Overall Compliance: No
Severity Score: 13.75			
Codes/Mitigation Info/Possible Solution		Field Measurements/Component Compliance

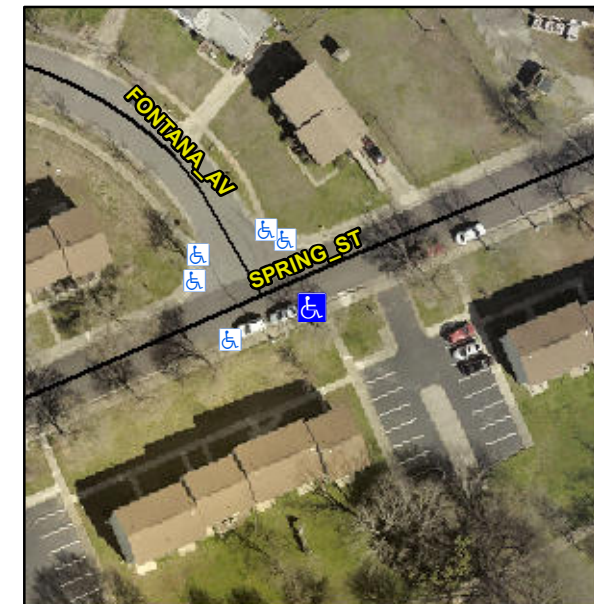
**Not Found, R304.2.2, R304.5.3**

Compliance	Description	Data	Compliance	Description	Data
N/A	Ramp Length (in)	59.0	No	Ramp Slope (%)	10.3
Yes	Ramp Width (in)	48.0	No	Ramp XSlope (%)	3.9
N/A	Flare Type LT	N/A	N/A	Flare Type RT	N/A
N/A	Flare Slope LT (%)	N/A	N/A	Flare Slope RT (%)	N/A
N/A	Flare Traversable LT?	N/A	N/A	Flare Traversable RT?	N/A
N/A	Landing Length (in)	N/A	N/A	DWS Provided?	N/A
N/A	Landing Width (in)	N/A	N/A	DWS Contrast?	N/A
N/A	Landing Slope (%)	N/A	N/A	DWS Length (in)	N/A
N/A	Landing X Slope (%)	N/A	N/A	DWS Full Width?	N/A
N/A	Landing Curb? (Y/N)	N/A	N/A	DWS Offset (in)	N/A
N/A	Shared Landing?	N/A			
N/A	Gutter Ponding?	N/A	N/A	Gutter Slope (%)	N/A
N/A	Gutter Lip Ht (in)	1.0	N/A	Gutter X Slope (%)	N/A
N/A	Painted X Walk1?	No	N/A	Painted X Walk2?	N/A
	X Walk 1 Direction	To N		X Walk 2 Direction	N/A
N/A	X Walk 1 Width (in)	N/A	N/A	X Walk 2 Width (in)	N/A
	X Walk 1 Slope (%)	2.8		X Walk 2 Slope (%)	N/A
	X Walk 1 X Slope (%)	3.6		X Walk 2 X Slope (%)	N/A

**Remove & Replace Entire Ramp.**
