# Access Compliance Report

## Public Rights-of-Way

### (Curb Ramps)

Intersection ID: 10737	Main Street: S_BRUNS_AV	Cross Street: SUMTER_AV	Location: SW
ADA ID: E1AA8E6EBA4C	Ramp Type: PerpDiag	Initial Pass/Fail: Fail	Overall Compliance: No
			Severity Score: 21.25

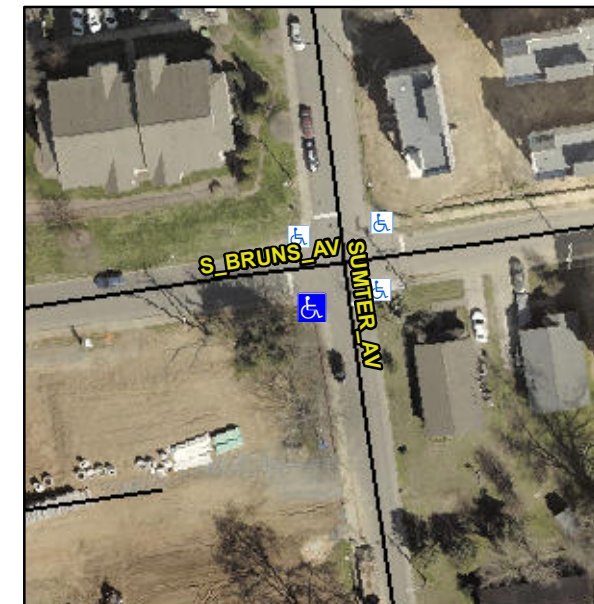
Compliance	Description	Data	Compliance	Description	Data
N/A	Ramp Length (in)	58.0	No	Ramp Slope (%)	10.2
No	Ramp Width (in)	37.5	Yes	Ramp XSlope (%)	1.6
N/A	Flare Type LT	N/A	N/A	Flare Type RT	N/A
N/A	Flare Slope LT (%)	N/A	N/A	Flare Slope RT (%)	N/A
N/A	Flare Traversable LT?	N/A	N/A	Flare Traversable RT?	N/A
N/A	Landing Length (in)	N/A	N/A	DWS Provided?	N/A
N/A	Landing Width (in)	N/A	N/A	DWS Contrast?	N/A
N/A	Landing Slope (%)	N/A	N/A	DWS Length (in)	N/A
N/A	Landing X Slope (%)	N/A	N/A	DWS Full Width?	N/A
N/A	Landing Curb? (Y/N)	N/A	N/A	DWS Offset (in)	N/A
N/A	Shared Landing?	N/A			
N/A	Gutter Ponding?	N/A	N/A	Gutter Slope (%)	N/A
N/A	Gutter Lip Ht (in)	N/A	N/A	Gutter X Slope (%)	N/A
N/A	Painted X Walk1?	No	N/A	Painted X Walk2?	No
	X Walk 1 Direction	To E		X Walk 2 Direction	To N
N/A	X Walk 1 Width (in)	N/A	N/A	X Walk 2 Width (in)	N/A
	X Walk 1 Slope (%)	4.5		X Walk 2 Slope (%)	6.7
	X Walk 1 X Slope (%)	3.4		X Walk 2 X Slope (%)	1.5

N/A	Ramp inside XWalk1?	N/A	N/A	Ramp inside XWalk2?	N/A
	Road Slope (%)	0.1	N/A	Clear Space?	N/A
	Road X Slope (%)	7.1	N/A	Clear Space to XWalk (in)	N/A
N/A	Any Obstructions?	N/A	N/A	Storm Grate/Utility Hazard?	N/A
	Obstruction Type			Storm Grate/Utility Type	
		N/A			N/A
			Yes	Surface Condition? (G/P)	Good

**Remove & Replace Curb Ramp With Two New Directional Ramps or Equivalent.**

**R304.5.1, R304.2.2**

Total Cost: \$ 3200.00
