Access Compliance Report

Public Rights-of-Way (Curb Ramps)

Intersection ID: 42579	Main Street: GERALDINE_POWE_DR	Cross Street: STROUD_PARK_CT	Location: NW
ADA ID: E1AB33ABE97A	Ramp Type: BlendTrans1	Initial Pass/Fail: Fail	Overall Compliance: No
		Severity Score: 10

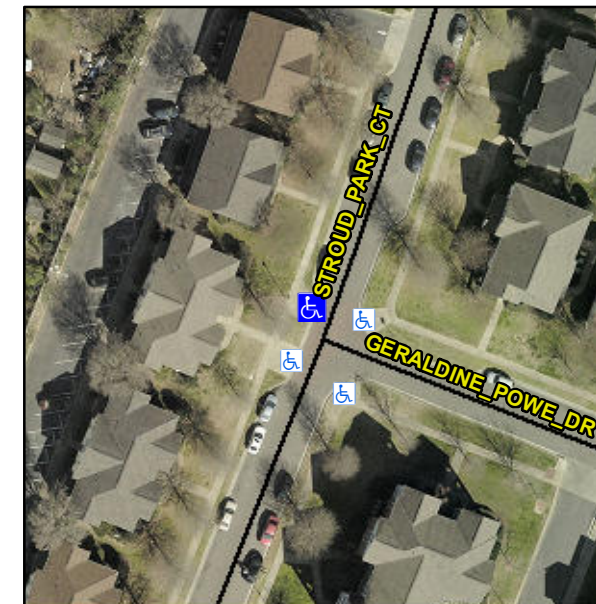
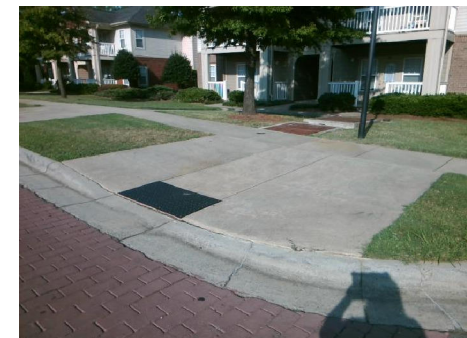
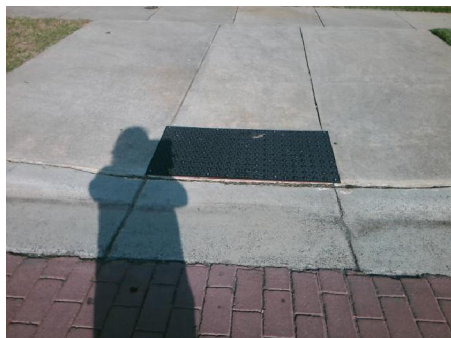
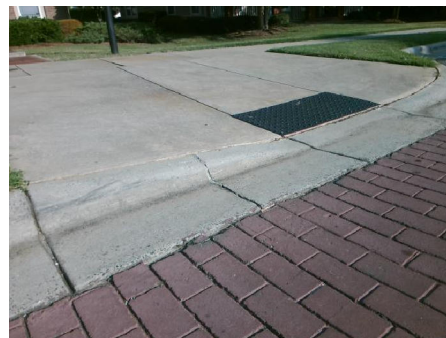
Not Found, R304.5.1, R304.5.3

Compliance	Description	Data	Compliance	Description	Data
N/A	Ramp Length (in)	132.0	Yes	BlendTrans Slope (%)	4.8
No	Ramp Width (in)	42.5	No	BlendTrans XSlope (%)	2.7
N/A	Flare Type LT	N/A	N/A	Flare Type RT	N/A
N/A	Flare Slope LT (%)	N/A	N/A	Flare Slope RT (%)	N/A
N/A	Flare Traversable LT?	N/A	N/A	Flare Traversable RT?	N/A
N/A	Landing Length (in)	N/A	N/A	DWS Provided?	N/A
N/A	Landing Width (in)	N/A	N/A	DWS Contrast?	N/A
N/A	Landing Slope (%)	N/A	N/A	DWS Length (in)	N/A
N/A	Landing X Slope (%)	N/A	N/A	DWS Full Width?	N/A
N/A	Landing Curb? (Y/N)	N/A	N/A	DWS Offset (in)	N/A
N/A	Shared Landing?	N/A			
N/A	Gutter Ponding?	N/A	N/A	Gutter Slope (%)	N/A
N/A	Gutter Lip Ht (in)	N/A	N/A	Gutter X Slope (%)	N/A
N/A	Painted X Walk1?	No	N/A	Painted X Walk2?	N/A
	X Walk 1 Direction	To S		X Walk 2 Direction	N/A
	X Walk 1 Width (in)	N/A		X Walk 2 Width (in)	N/A
	X Walk 1 Slope (%)	3.3		X Walk 2 Slope (%)	N/A
	X Walk 1 X Slope (%)	2.2		X Walk 2 X Slope (%)	N/A

N/A	Ramp inside XWalk1?	N/A	N/A	Ramp inside XWalk2?	N/A
	Road Slope (%)	2.2		Clear Space?	N/A
	Road X Slope (%)	3.3	N/A	Clear Space to XWalk (in)	N/A
N/A	Any Obstructions?	N/A	N/A	Storm Grate/Utility Hazard?	N/A
	Obstruction Type			Storm Grate/Utility Type	
		N/A			N/A
			Yes	Surface Condition? (G/P)	Good
			No	Curb Slope (%)	10.3

Remove & Replace Curb Ramp With Two New Directional Ramps or Equivalent.
