Access Compliance Report

Public Rights-of-Way

(Curb Ramps)

| Intersection ID: 3164 | Main Street: MT_HOLLY-HUNTERSVILLE_RD | Cross Street: W_W_T_HARRIS_BV | Location: SW |

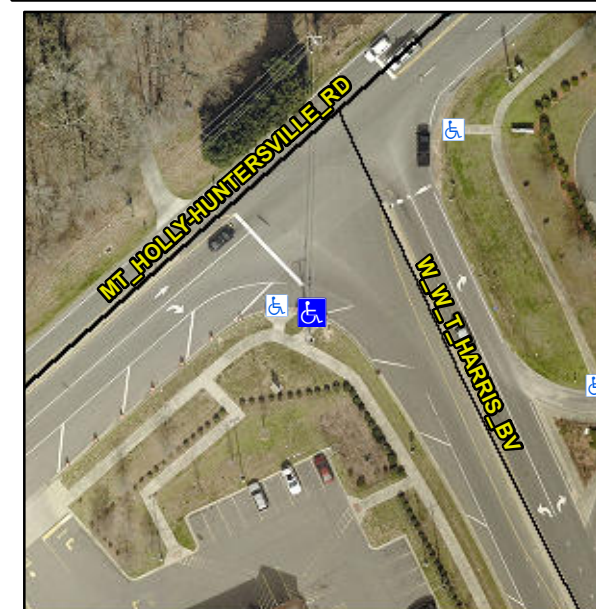
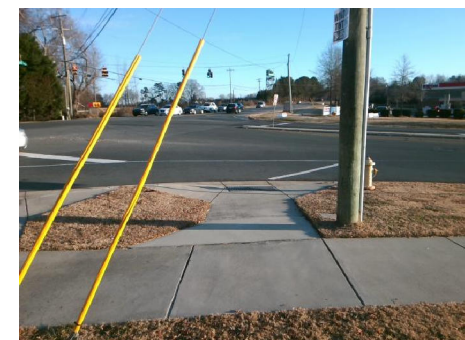
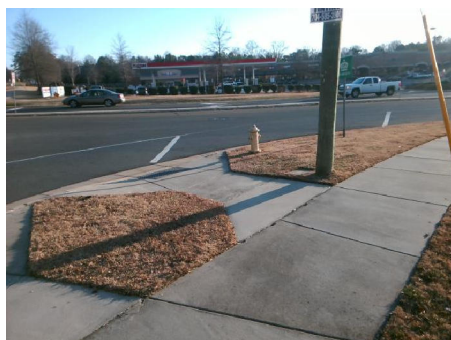
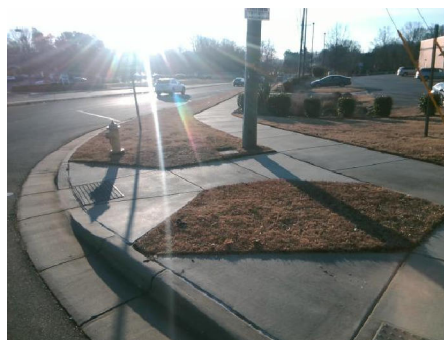
| ADA ID: E1AC6CF4EEE3 | Ramp Type: BlendTrans1 | Initial Pass/Fail: Fail | Overall Compliance: No |
| Severity Score: 12.5 | | | |

R304.5.3

| Compliance | Description | Data | Compliance | Description | Data |
|---|---|---|---|---|---|
| Yes | Ramp Width (in) | 52.0 | No | BlendTrans XSlope (%) | 5.7 |

Remove & Replace Curb Ramp With Two New Directional Ramps or Equivalent.

Total Cost: \$ 3200.00
