Access Compliance Report

Public Rights-of-Way

(Curb Ramps)

Intersection ID: 10012559	Main Street: IKEA_BV	Cross Street: N/A	Location: E
ADA ID: E1B2934BCF1A	Ramp Type: PerpDiag	Initial Pass/Fail: Fail	Overall Compliance: No
		Severity Score: 25

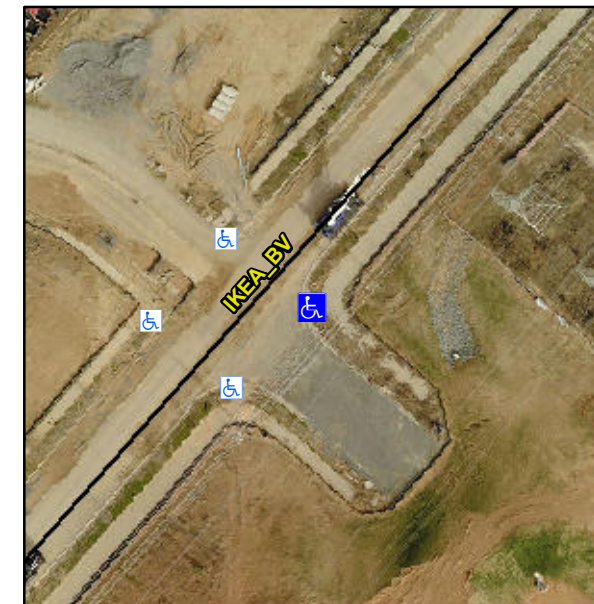
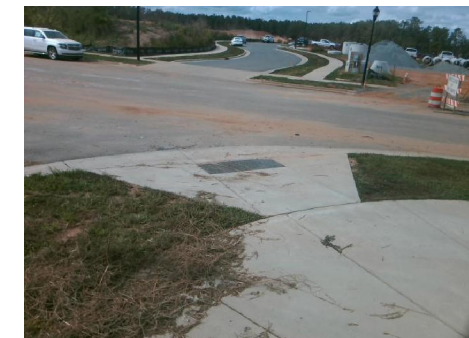
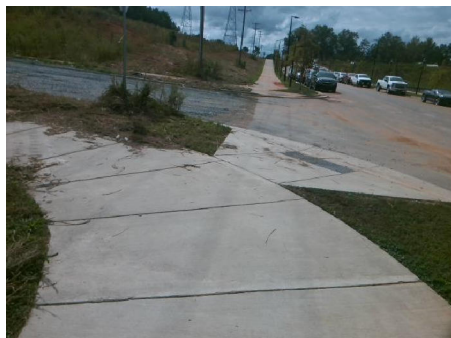
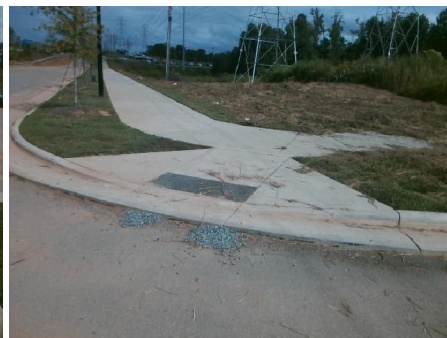
Compliance	Description	Data	Compliance	Description	Data
N/A	Ramp Length (in)	96.0	Yes	Ramp Slope (%)	6.2
Yes	Ramp Width (in)	59.0	No	Ramp XSlope (%)	7.7
N/A	Flare Type LT	N/A	N/A	Flare Type RT	N/A
N/A	Flare Slope LT (%)	N/A	N/A	Flare Slope RT (%)	N/A
N/A	Flare Traversable LT?	N/A	N/A	Flare Traversable RT?	N/A
N/A	Landing Length (in)	N/A	N/A	DWS Provided?	N/A
N/A	Landing Width (in)	N/A	N/A	DWS Contrast?	N/A
N/A	Landing Slope (%)	N/A	N/A	DWS Length (in)	N/A
N/A	Landing X Slope (%)	N/A	N/A	DWS Full Width?	N/A
N/A	Landing Curb? (Y/N)	N/A	N/A	DWS Offset (in)	N/A
N/A	Shared Landing?	N/A			
N/A	Gutter Ponding?	N/A	N/A	Gutter Slope (%)	N/A
N/A	Gutter Lip Ht (in)	N/A	N/A	Gutter X Slope (%)	N/A
N/A	Painted X Walk1?	No	N/A	Painted X Walk2?	No
	X Walk 1 Direction	To NW		X Walk 2 Direction	To SW
N/A	X Walk 1 Width (in)	N/A	N/A	X Walk 2 Width (in)	N/A
	X Walk 1 Slope (%)	3.5		X Walk 2 Slope (%)	0.7
	X Walk 1 X Slope (%)	0.9		X Walk 2 X Slope (%)	3.0

N/A	Ramp inside XWalk1?	N/A	N/A	Ramp inside XWalk2?	N/A
	Road Slope (%)	3.2	N/A	Clear Space?	N/A
	Road X Slope (%)	1.3	N/A	Clear Space to XWalk (in)	N/A
N/A	Any Obstructions?	N/A	N/A	Storm Grate/Utility Hazard?	N/A
	Obstruction Type			Storm Grate/Utility Type	
		N/A			N/A
			Yes	Surface Condition? (G/P)	Good

Remove & Replace Curb Ramp With Two New Directional Ramps or Equivalent.

R304.5.3
