# Access Compliance Report

## Public Rights-of-Way

### (Curb Ramps)

| Intersection ID: 10024831 | Main Street: DENMARK_RD | Cross Street: N/A | Location: E |

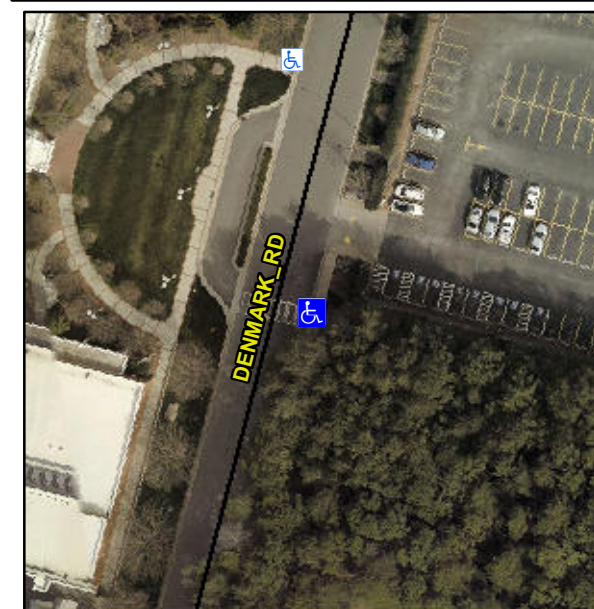
| ADA ID: E1B64BCEA15F | Ramp Type: Perp | Initial Pass/Fail: Fail | Overall Compliance: No |

**R304.2.2**

| Compliance | Description | Data | Compliance | Description | Data |
|---|---|---|---|---|---|
| N/A | Ramp Length (in) | 61.0 | No | Ramp Slope (%) | 13.0 |

**Remove & Replace Entire Ramp.**

Total Cost: \$ 1850.00
