# Access Compliance Report

## Public Rights-of-Way

### (Curb Ramps)

Intersection ID: 8513	Main Street: MCARTHUR_AV	Cross Street: MONTREAT_ST	Location: SE
ADA ID: E1BA1767DD3D	Ramp Type: Perp	Initial Pass/Fail: Fail	Overall Compliance: No
Severity Score: 21.25			
Codes/Mitigation Info/Possible Solution		Field Measurements/Component Compliance

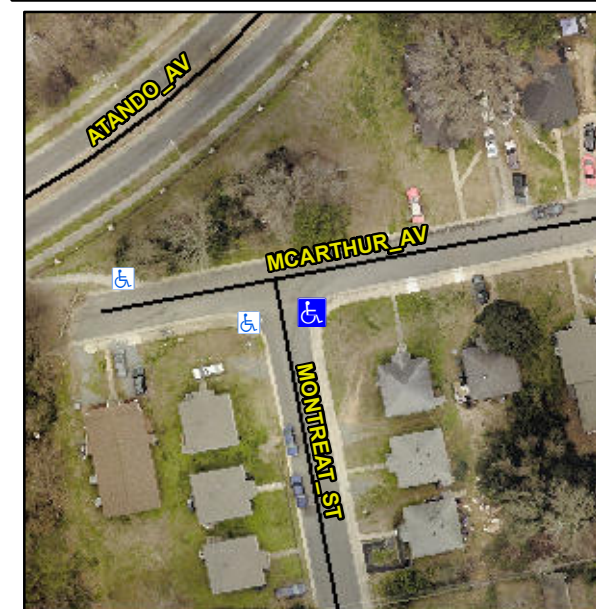
**Not Found, R304.5.1, R304.2.2**

Compliance	Description	Data	Compliance	Description	Data
N/A	Ramp Length (in)	57.0	No	Ramp Slope (%)	8.9
No	Ramp Width (in)	41.0	Yes	Ramp XSlope (%)	1.9
N/A	Flare Type LT	N/A	N/A	Flare Type RT	N/A
N/A	Flare Slope LT (%)	N/A	N/A	Flare Slope RT (%)	N/A
N/A	Flare Traversable LT?	N/A	N/A	Flare Traversable RT?	N/A
N/A	Landing Length (in)	N/A	N/A	DWS Provided?	N/A
N/A	Landing Width (in)	N/A	N/A	DWS Contrast?	N/A
N/A	Landing Slope (%)	N/A	N/A	DWS Length (in)	N/A
N/A	Landing X Slope (%)	N/A	N/A	DWS Full Width?	N/A
N/A	Landing Curb? (Y/N)	N/A	N/A	DWS Offset (in)	N/A
N/A	Shared Landing?	N/A			
N/A	Gutter Ponding?	N/A	N/A	Gutter Slope (%)	N/A
N/A	Gutter Lip Ht (in)	N/A	N/A	Gutter X Slope (%)	N/A
N/A	Painted X Walk1?	No	N/A	Painted X Walk2?	N/A
	X Walk 1 Direction	To W		X Walk 2 Direction	N/A
N/A	X Walk 1 Width (in)	N/A	N/A	X Walk 2 Width (in)	N/A
	X Walk 1 Slope (%)	1.5		X Walk 2 Slope (%)	N/A
	X Walk 1 X Slope (%)	3.4		X Walk 2 X Slope (%)	N/A

N/A	Ramp inside XWalk1?	N/A	N/A	Ramp inside XWalk2?	N/A
	Road Slope (%)	N/A	N/A	Clear Space?	N/A
	Road X Slope (%)	N/A	N/A	Clear Space to XWalk (in)	N/A
N/A	Any Obstructions?	N/A	N/A	Storm Grate/Utility Hazard?	N/A
	Obstruction Type			Storm Grate/Utility Type	
		N/A			N/A
		Yes		Surface Condition? (G/P)	Good

**Remove & Replace Entire Ramp.**

Total Cost: \$ 1850.00
