Access Compliance Report

Public Rights-of-Way

(Curb Ramps)

Intersection ID: 53124	Main Street: SHARON_VIEW_RD	Cross Street: CALVET_CT	Location: NE
ADA ID: E1BB319C6526	Ramp Type: PerpDiag	Initial Pass/Fail: Fail	Overall Compliance: No
Severity Score: 22.5			
Codes/Mitigation Info/Possible Solution		Field Measurements/Component Compliance

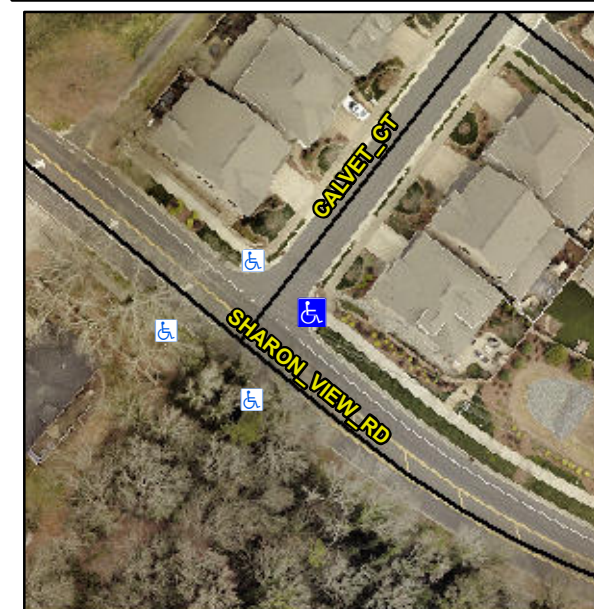
Compliance	Description	Data	Compliance	Description	Data
N/A	Ramp Length (in)	71.0	No	Ramp Slope (%)	10.6
No	Ramp Width (in)	47.0	No	Ramp XSlope (%)	2.7
N/A	Flare Type LT	N/A	N/A	Flare Type RT	N/A
N/A	Flare Slope LT (%)	N/A	N/A	Flare Slope RT (%)	N/A
N/A	Flare Traversable LT?	N/A	N/A	Flare Traversable RT?	N/A
N/A	Landing Length (in)	N/A	N/A	DWS Provided?	N/A
N/A	Landing Width (in)	N/A	N/A	DWS Contrast?	N/A
N/A	Landing Slope (%)	N/A	N/A	DWS Length (in)	N/A
N/A	Landing X Slope (%)	N/A	N/A	DWS Full Width?	N/A
N/A	Landing Curb? (Y/N)	N/A	N/A	DWS Offset (in)	N/A
N/A	Shared Landing?	N/A			
N/A	Gutter Ponding?	N/A	N/A	Gutter Slope (%)	N/A
N/A	Gutter Lip Ht (in)	N/A	N/A	Gutter X Slope (%)	N/A
N/A	Painted X Walk1?	No	N/A	Painted X Walk2?	No
	X Walk 1 Direction	To NW		X Walk 2 Direction	To SW
N/A	X Walk 1 Width (in)	N/A	N/A	X Walk 2 Width (in)	N/A
	X Walk 1 Slope (%)	3.3		X Walk 2 Slope (%)	2.1
	X Walk 1 X Slope (%)	0.1		X Walk 2 X Slope (%)	3.4

N/A	Ramp inside XWalk1?	N/A	N/A	Ramp inside XWalk2?	N/A
	Road Slope (%)	4.7	N/A	Clear Space?	N/A
	Road X Slope (%)	1.4	N/A	Clear Space to XWalk (in)	N/A
N/A	Any Obstructions?	N/A	N/A	Storm Grate/Utility Hazard?	N/A
	Obstruction Type			Storm Grate/Utility Type	
		N/A			N/A
			Yes	Surface Condition? (G/P)	Good

Possible Solutions:

Remove & Replace Curb Ramp With Two New Directional Ramps or Equivalent.

R304.5.1, R304.2.2, R304.5.3
