# Access Compliance Report

## Public Rights-of-Way

### (Curb Ramps)

| Intersection ID: 46811 | Main Street: ARBOR_VISTA_DR | Cross Street: ROSE_CREEK_CT | Location: E |

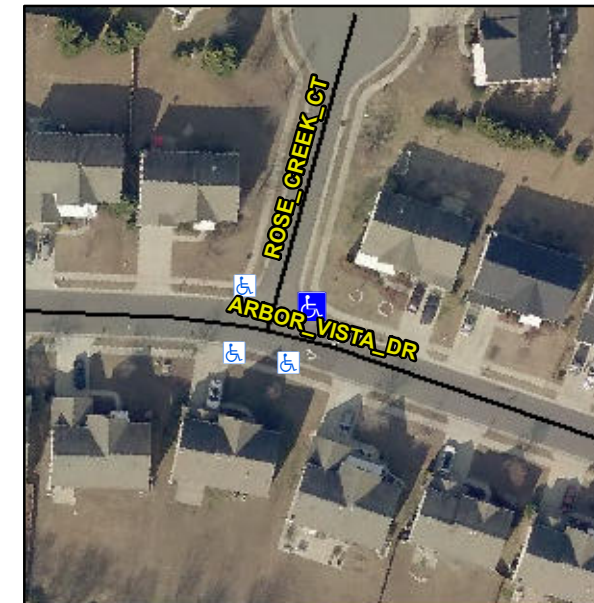
**Not Found, R304.2.1, R304.5.3, R305, R302.7.2**

| Compliance | Description | Data | Compliance | Description | Data |
|---|---|---|---|---|---|
| No | Landing Length (in) | 46.0 | No | DWS Provided? | No |
| No | Landing Width (in) | 42.0 | N/A | DWS Contrast? | No |
| No | Landing X Slope (%) | 4.1 | N/A | DWS Full Width? | No |
| No | Gutter Lip Ht (in) | 0.5 | No | Gutter X Slope (%) | 2.3 |

**Remove & Replace Curb Ramp With Two New Directional Ramps or Equivalent. Remove & Replace Gutter.**

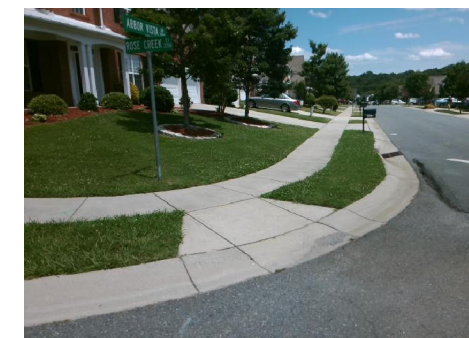
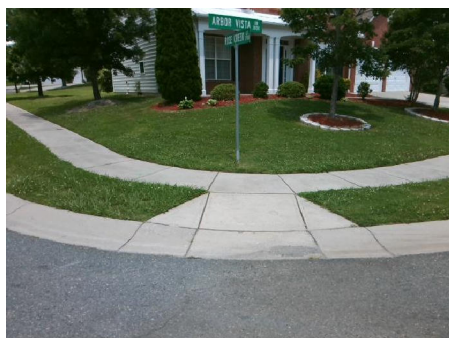
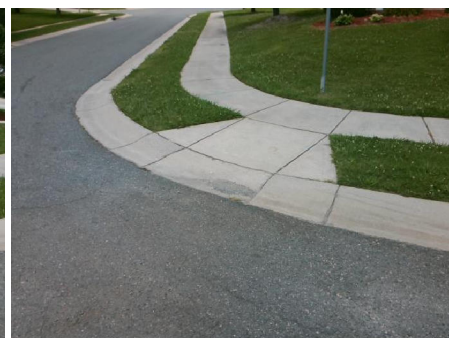
Street 1 Name ROSE CREEK CT  
 Stop Condition-Street 2 StopSign  
 Street 2 Name ARBOR VISTA DR  
 Stop Condition-Street 1 None
