Access Compliance Report

Public Rights-of-Way

(Curb Ramps)

Intersection ID: 10033070	Main Street: NORTH_COMMUNITY_HOUSE_RD	Cross Street: N/A	Location: SW
ADA ID: E1CAF7444EDB	Ramp Type: Perp	Initial Pass/Fail: Fail	Overall Compliance: No
Codes/Mitigation Info/Possible Solution		Field Measurements/Component Compliance	
Severity Score: 12.5

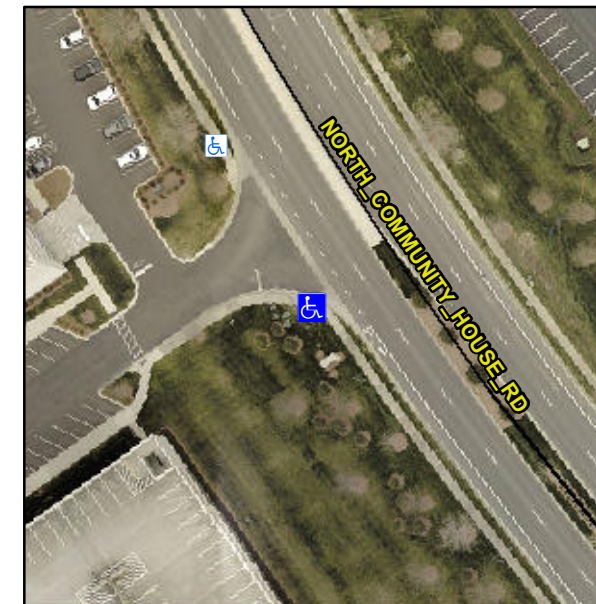
Not Found, R304.2.2

Compliance	Description	Data	Compliance	Description	Data
N/A	Ramp Length (in)	59.5	No	Ramp Slope (%)	11.3
Yes	Ramp Width (in)	58.0	Yes	Ramp XSlope (%)	1.2
N/A	Flare Type LT	N/A	N/A	Flare Type RT	N/A
N/A	Flare Slope LT (%)	N/A	N/A	Flare Slope RT (%)	N/A
N/A	Flare Traversable LT?	N/A	N/A	Flare Traversable RT?	N/A
N/A	Landing Length (in)	N/A	N/A	DWS Provided?	N/A
N/A	Landing Width (in)	N/A	N/A	DWS Contrast?	N/A
N/A	Landing Slope (%)	N/A	N/A	DWS Length (in)	N/A
N/A	Landing X Slope (%)	N/A	N/A	DWS Full Width?	N/A
N/A	Landing Curb? (Y/N)	N/A	N/A	DWS Offset (in)	N/A
N/A	Shared Landing?	N/A			
N/A	Gutter Ponding?	N/A	N/A	Gutter Slope (%)	N/A
N/A	Gutter Lip Ht (in)	N/A	N/A	Gutter X Slope (%)	N/A
N/A	Painted X Walk1?	No	N/A	Painted X Walk2?	N/A
	X Walk 1 Direction	To NW		X Walk 2 Direction	N/A
N/A	X Walk 1 Width (in)	N/A	N/A	X Walk 2 Width (in)	N/A
	X Walk 1 Slope (%)	5.4		X Walk 2 Slope (%)	N/A
	X Walk 1 X Slope (%)	6.3		X Walk 2 X Slope (%)	N/A

Possible Solutions:

Remove & Replace Entire Ramp.
