Access Compliance Report

Public Rights-of-Way

(Curb Ramps)

Intersection ID: 22578	Main Street: MAGNOLIA_BRIDGE_RD	Cross Street: QUAIL_HOLLOW_RD	Location: SW
ADA ID: E1CB91EFEF22	Ramp Type: PerpDiag	Initial Pass/Fail: Fail	Overall Compliance: No
		Severity Score: 47.5

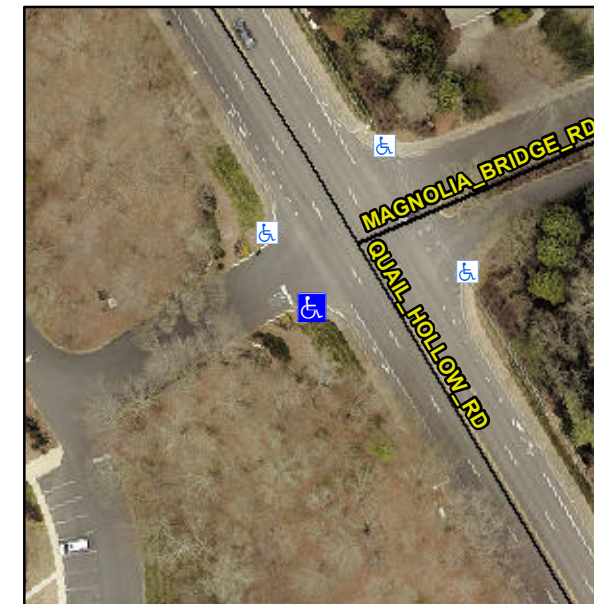
Compliance	Description	Data	Compliance	Description	Data
N/A	Ramp Length (in)	61.0	No	Ramp Slope (%)	8.8
No	Ramp Width (in)	31.0	Yes	Ramp XSlope (%)	1.4
N/A	Flare Type LT	N/A	N/A	Flare Type RT	N/A
N/A	Flare Slope LT (%)	N/A	N/A	Flare Slope RT (%)	N/A
N/A	Flare Traversable LT?	N/A	N/A	Flare Traversable RT?	N/A
N/A	Landing Length (in)	N/A	N/A	DWS Provided?	N/A
N/A	Landing Width (in)	N/A	N/A	DWS Contrast?	N/A
N/A	Landing Slope (%)	N/A	N/A	DWS Length (in)	N/A
N/A	Landing X Slope (%)	N/A	N/A	DWS Full Width?	N/A
N/A	Landing Curb? (Y/N)	N/A	N/A	DWS Offset (in)	N/A
N/A	Shared Landing?	N/A			
N/A	Gutter Ponding?	N/A	N/A	Gutter Slope (%)	N/A
N/A	Gutter Lip Ht (in)	N/A	N/A	Gutter X Slope (%)	N/A
N/A	Painted X Walk1?	No	N/A	Painted X Walk2?	No
	X Walk 1 Direction	To E		X Walk 2 Direction	To NW
N/A	X Walk 1 Width (in)	N/A	N/A	X Walk 2 Width (in)	N/A
	X Walk 1 Slope (%)	0.7		X Walk 2 Slope (%)	3.0
	X Walk 1 X Slope (%)	2.1		X Walk 2 X Slope (%)	0.8

N/A	Ramp inside XWalk1?	N/A	N/A	Ramp inside XWalk2?	N/A
	Road Slope (%)	1.2	N/A	Clear Space?	N/A
	Road X Slope (%)	1.4	N/A	Clear Space to XWalk (in)	N/A
N/A	Any Obstructions?	N/A	N/A	Storm Grate/Utility Hazard?	N/A
	Obstruction Type			Storm Grate/Utility Type	
		N/A			N/A
			Yes	Surface Condition? (G/P)	Good

Remove & Replace Curb Ramp With Two New Directional Ramps or Equivalent.

Not Found, R304.5.1, R304.2.2

Total Cost: \$ 3200.00
