Access Compliance Report

Public Rights-of-Way

(Curb Ramps)

Intersection ID: 9934	Main Street: N_PINE_ST	Cross Street: W_26TH_ST	Location: N
ADA ID: E1D04C8AC0EA	Ramp Type: BlendTrans2	Initial Pass/Fail: Pass	Overall Compliance: No
			Severity Score: 17.75

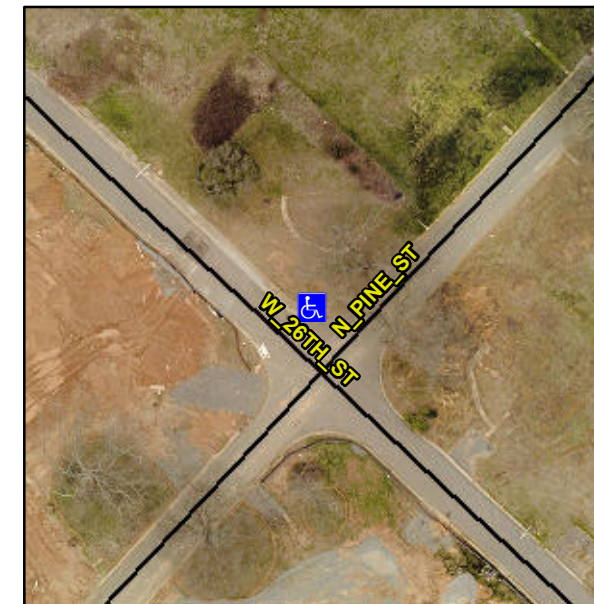
VEGETATION OVERGROWTH, NO RT SW

Compliance	Description	Data	Compliance	Description	Data
N/A	Ramp Length (in)	50.0	Yes	BlendTrans Slope (%)	3.3
Yes	Ramp Width (in)	48.0	No	BlendTrans XSlope (%)	4.5
N/A	Flare Type LT	None	N/A	Flare Type RT	None
N/A	Flare Slope LT (%)	N/A	N/A	Flare Slope RT (%)	N/A
N/A	Flare Traversable LT?	N/A	N/A	Flare Traversable RT?	N/A
N/A	Landing Length (in)	N/A	Yes	DWS Provided?	Yes
N/A	Landing Width (in)	N/A	Yes	DWS Contrast?	Yes
N/A	Landing Slope (%)	N/A	Yes	DWS Length (in)	24.0
N/A	Landing X Slope (%)	N/A	No	DWS Full Width?	No
N/A	Landing Curb? (Y/N)	No	No	DWS Offset (in)	10.0
N/A	Shared Landing?	No			
No	Gutter Ponding?	Yes	Yes	Gutter Slope (%)	0.1
No	Gutter Lip Ht (in)	1.5	No	Gutter X Slope (%)	5.7
N/A	Painted X Walk1?	No	N/A	Painted X Walk2?	N/A
	X Walk 1 Direction	To SW		X Walk 2 Direction	N/A
	X Walk 1 Width (in)	N/A		X Walk 2 Width (in)	N/A
	X Walk 1 Slope (%)	2.4		X Walk 2 Slope (%)	N/A
	X Walk 1 X Slope (%)	3.9		X Walk 2 X Slope (%)	N/A

N/A	Ramp inside XWalk1?	N/A	N/A	Ramp inside XWalk2?	N/A
	Road Slope (%)	3.9		Clear Space?	Yes
	Road X Slope (%)	2.4	N/A	Clear Space to XWalk (in)	N/A
Yes	Any Obstructions?	No	Yes	Storm Grate/Utility Hazard?	No
	Obstruction Type			Storm Grate/Utility Type	
		N/A			N/A
			Yes	Surface Condition? (G/P)	Good
			No	Curb Slope (%)	14.9

Remove & Replace Curb Ramp With Two New Directional Ramps or Equivalent. Remove & Replace Gutter.
