Access Compliance Report

Public Rights-of-Way

(Curb Ramps)

Intersection ID: 30304	Main Street: CHALLENGER_DR	Cross Street: EUROSTAR_DR	Location: N
ADA ID: E1D3085911BF	Ramp Type: PerpDiag	Initial Pass/Fail: Fail	Overall Compliance: No
Severity Score: 26.25			
Codes/Mitigation Info/Possible Solution		Field Measurements/Component Compliance

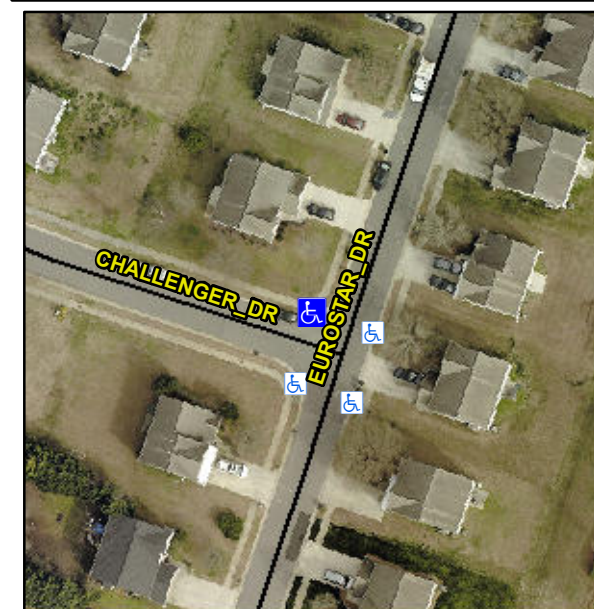
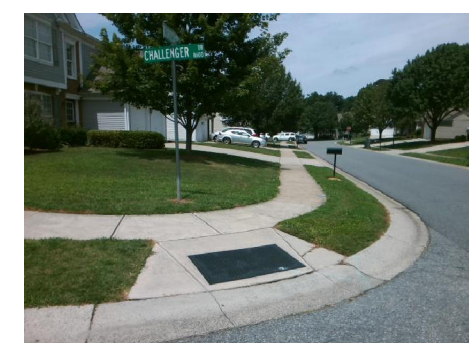
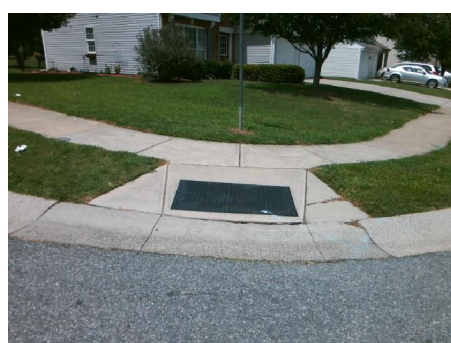
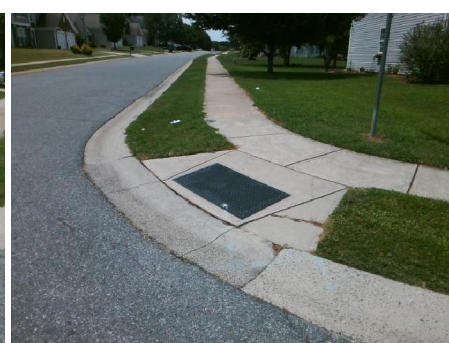
Not Found, R304.2.2, R304.5.3

Compliance	Description	Data	Compliance	Description	Data
N/A	Ramp Length (in)	48.5	No	Ramp Slope (%)	13.3
Yes	Ramp Width (in)	52.0	No	Ramp XSlope (%)	4.5
N/A	Flare Type LT	N/A	N/A	Flare Type RT	N/A
N/A	Flare Slope LT (%)	N/A	N/A	Flare Slope RT (%)	N/A
N/A	Flare Traversable LT?	N/A	N/A	Flare Traversable RT?	N/A
N/A	Landing Length (in)	N/A	N/A	DWS Provided?	N/A
N/A	Landing Width (in)	N/A	N/A	DWS Contrast?	N/A
N/A	Landing Slope (%)	N/A	N/A	DWS Length (in)	N/A
N/A	Landing X Slope (%)	N/A	N/A	DWS Full Width?	N/A
N/A	Landing Curb? (Y/N)	N/A	N/A	DWS Offset (in)	N/A
N/A	Shared Landing?	N/A			
N/A	Gutter Ponding?	N/A	N/A	Gutter Slope (%)	N/A
N/A	Gutter Lip Ht (in)	N/A	N/A	Gutter X Slope (%)	N/A
N/A	Painted X Walk1?	No	N/A	Painted X Walk2?	No
	X Walk 1 Direction	To SW		X Walk 2 Direction	To SE
N/A	X Walk 1 Width (in)	N/A	N/A	X Walk 2 Width (in)	N/A
	X Walk 1 Slope (%)	3.7		X Walk 2 Slope (%)	0.9
	X Walk 1 X Slope (%)	2.6		X Walk 2 X Slope (%)	3.0

N/A	Ramp inside XWalk1?	N/A	N/A	Ramp inside XWalk2?	N/A
	Road Slope (%)	4.0	N/A	Clear Space?	N/A
	Road X Slope (%)	2.4	N/A	Clear Space to XWalk (in)	N/A
N/A	Any Obstructions?	N/A	N/A	Storm Grate/Utility Hazard?	N/A
	Obstruction Type			Storm Grate/Utility Type	
		N/A			N/A
			Yes	Surface Condition? (G/P)	Good

Remove & Replace Curb Ramp With Two New Directional Ramps or Equivalent.
