# Access Compliance Report

## Public Rights-of-Way

| Intersection ID: 31684 | Main Street: HYACINTH_CT | Cross Street: WILLIE_WORRELL_DR | Location: SW |
| ADA ID: E1DF705E3CF7 | Ramp Type: PerpDiag | Initial Pass/Fail: Fail | Overall Compliance: No |

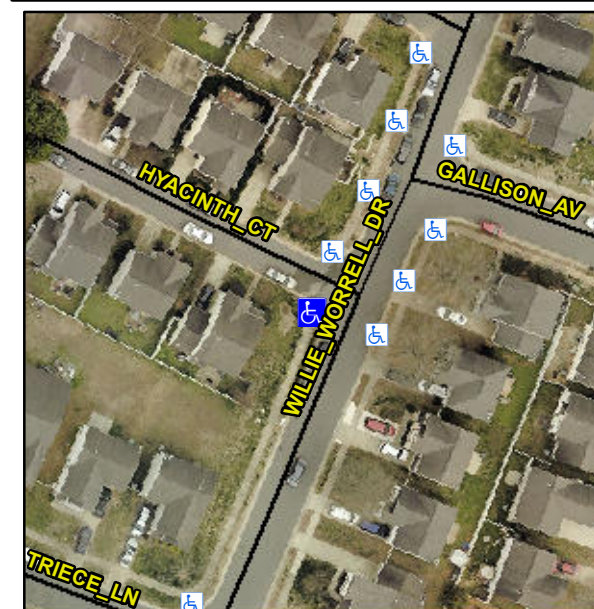
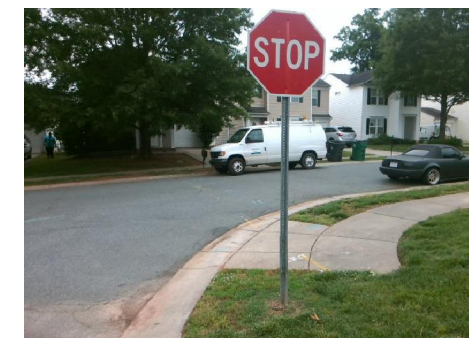
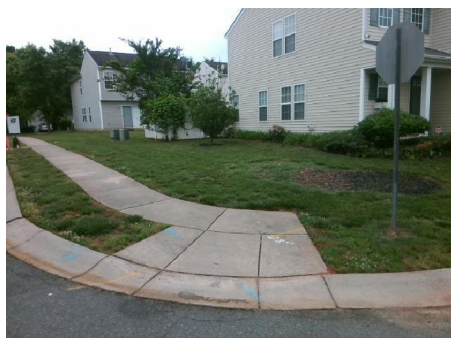
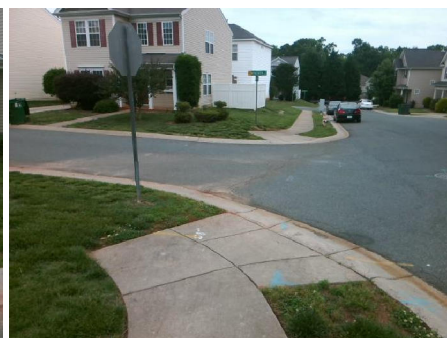
| Severity Score: 55 | | | |

**Not Found, R304.5.1, R304.2.2, R304.5.3**

| Compliance | Description | Data | Compliance | Description | Data |
|---|---|---|---|---|---|
| N/A | Ramp Length (in) | 47.0 | No | Ramp Slope (%) | 10.5 |
| No | Ramp Width (in) | 32.0 | No | Ramp XSlope (%) | 7.2 |

**Remove & Replace Curb Ramp With Two New Directional Ramps or Equivalent.**

Total Cost: \$ 3200.00
