# Access Compliance Report

## Public Rights-of-Way

### (Curb Ramps)

| Intersection ID: 45512 | Main Street: GINHOUSE_LN | Cross Street: HEDGEROW_PARK_RD | Location: NW |

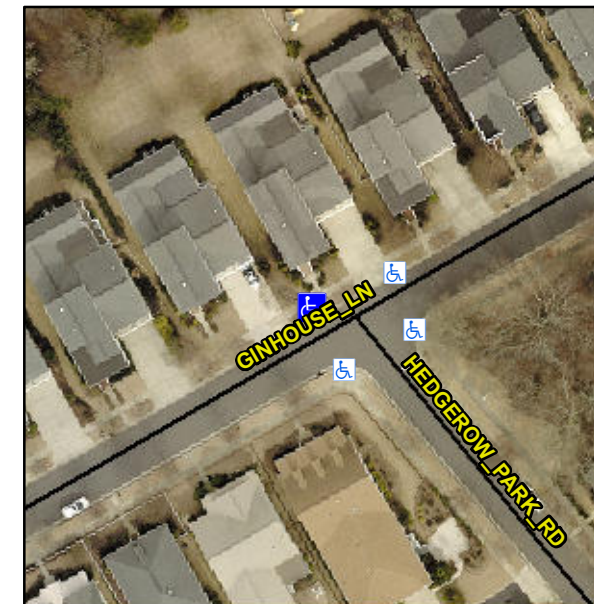
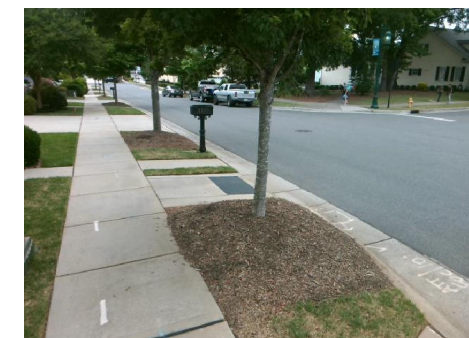
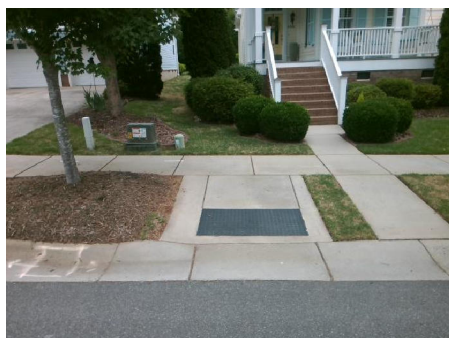
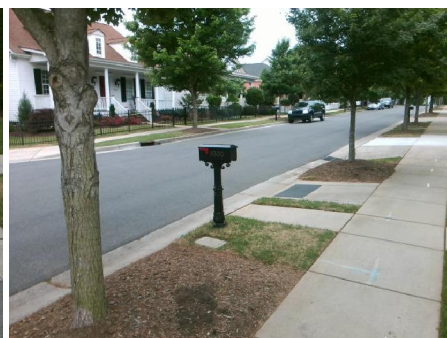
| ADA ID: E1E8D5598617 | Ramp Type: Perp | Initial Pass/Fail: Fail | Overall Compliance: No |

| Severity Score: 13.75 | | | |

**R304.2.2, R304.5.3**

| Compliance | Description | Data | Compliance | Description | Data |
|---|---|---|---|---|---|
| N/A | Ramp Length (in) | 73.0 | No | Ramp Slope (%) | 10.5 |
| Yes | Ramp Width (in) | 48.0 | No | Ramp XSlope (%) | 2.9 |

**Remove & Replace Entire Ramp.**

Total Cost: \$ 1850.00
