Access Compliance Report

Public Rights-of-Way

(Curb Ramps)

Intersection ID: 48634	Main Street: GRANDE_HEIGHTS_DR	Cross Street: DOMINION_CREST_DR	Location: NW
ADA ID: E1E8D79CC746	Ramp Type: Perp	Initial Pass/Fail: Fail	Overall Compliance: No
Severity Score: 8.75			
Codes/Mitigation Info/Possible Solution		Field Measurements/Component Compliance

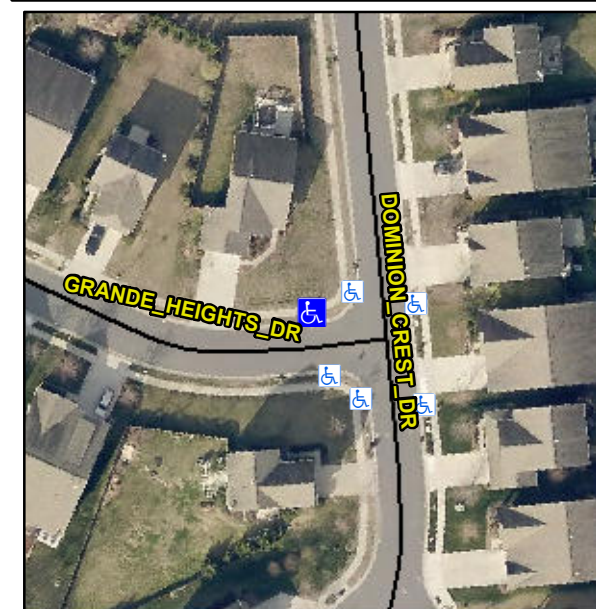
Compliance	Description	Data	Compliance	Description	Data
N/A	Ramp Length (in)	47.0	Yes	Ramp Slope (%)	5.7
No	Ramp Width (in)	46.5	Yes	Ramp XSlope (%)	0.9
N/A	Flare Type LT	N/A	N/A	Flare Type RT	N/A
N/A	Flare Slope LT (%)	N/A	N/A	Flare Slope RT (%)	N/A
N/A	Flare Traversable LT?	N/A	N/A	Flare Traversable RT?	N/A
N/A	Landing Length (in)	N/A	N/A	DWS Provided?	N/A
N/A	Landing Width (in)	N/A	N/A	DWS Contrast?	N/A
N/A	Landing Slope (%)	N/A	N/A	DWS Length (in)	N/A
N/A	Landing X Slope (%)	N/A	N/A	DWS Full Width?	N/A
N/A	Landing Curb? (Y/N)	N/A	N/A	DWS Offset (in)	N/A
N/A	Shared Landing?	N/A			
N/A	Gutter Ponding?	N/A	N/A	Gutter Slope (%)	N/A
N/A	Gutter Lip Ht (in)	N/A	N/A	Gutter X Slope (%)	N/A
N/A	Painted X Walk1?	No	N/A	Painted X Walk2?	N/A
	X Walk 1 Direction	To S		X Walk 2 Direction	N/A
N/A	X Walk 1 Width (in)	N/A	N/A	X Walk 2 Width (in)	N/A
	X Walk 1 Slope (%)	0.9		X Walk 2 Slope (%)	N/A
	X Walk 1 X Slope (%)	0.3		X Walk 2 X Slope (%)	N/A

N/A	Ramp inside XWalk1?	N/A	N/A	Ramp inside XWalk2?	N/A
	Road Slope (%)	N/A	N/A	Clear Space?	N/A
	Road X Slope (%)	N/A	N/A	Clear Space to XWalk (in)	N/A
N/A	Any Obstructions?	N/A	N/A	Storm Grate/Utility Hazard?	N/A
	Obstruction Type			Storm Grate/Utility Type	
		N/A			N/A
			Yes	Surface Condition? (G/P)	Good

Possible Solutions:

Remove & Replace Entire Ramp.

PROW/ADA:

R304.5.1
