Access Compliance Report

Public Rights-of-Way

| Intersection ID: 25757 | Main Street: BANNINGTON_RD | Cross Street: SHANNON_WILLOW_RD | Location: SE |
| ADA ID: E1E9B8057089 | Ramp Type: PerpDiag | Initial Pass/Fail: Fail | Overall Compliance: No |

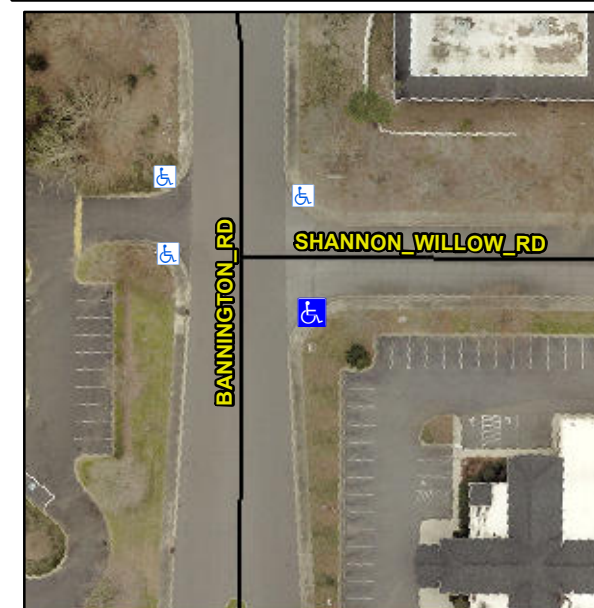
| Severity Score: 12.5 | | | |

R304.5.3

| Compliance | Description | Data | Compliance | Description | Data |
|---|---|---|---|---|---|
| N/A | Ramp Length (in) | 60.0 | Yes | Ramp Slope (%) | 8.1 |
| Yes | Ramp Width (in) | 48.0 | No | Ramp XSlope (%) | 5.4 |

Remove & Replace Curb Ramp With Two New Directional Ramps or Equivalent.

Total Cost: \$ 3200.00
