# Access Compliance Report

## Public Rights-of-Way

### (Curb Ramps)

| Intersection ID: 28409 | Main Street: LAUREL_RUN_DR | Cross Street: LAUREL_RUN_DR | Location: W |

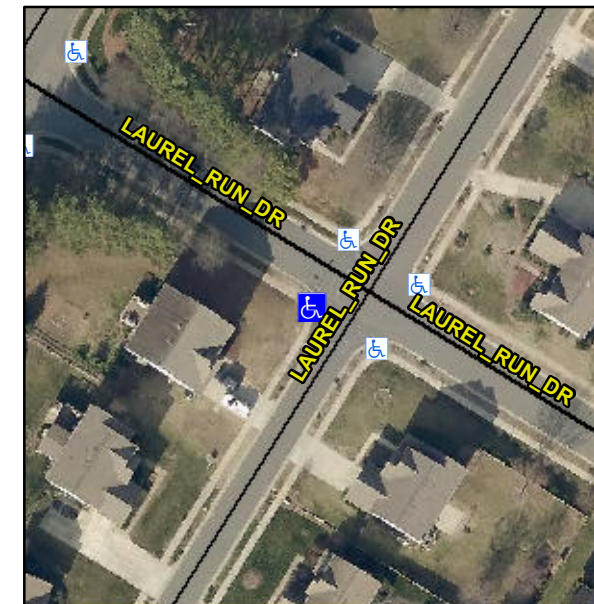
| ADA ID: E1F6B875BEBE | Ramp Type: PerpDiag | Initial Pass/Fail: Fail | Overall Compliance: No |
| Severity Score: 25 | | | |

**Not Found, R304.5.3**

| Compliance | Description | Data | Compliance | Description | Data |
|---|---|---|---|---|---|
| N/A | Ramp Length (in) | 48.0 | Yes | Ramp Slope (%) | 5.2 |
| Yes | Ramp Width (in) | 60.0 | No | Ramp XSlope (%) | 14.5 |

**Remove & Replace Curb Ramp With Two New Directional Ramps or Equivalent.**

Total Cost: \$ 3200.00
