# Access Compliance Report

## Public Rights-of-Way

### (Curb Ramps)

Intersection ID: 52450	Main Street: TRANQUIL_OAK_PL	Cross Street: MOSS_LN	Location: SE
ADA ID: E1F80ACD8CBA	Ramp Type: BlendTrans1	Initial Pass/Fail: Fail	Overall Compliance: No
Severity Score: 1.25			
Codes/Mitigation Info/Possible Solution		Field Measurements/Component Compliance

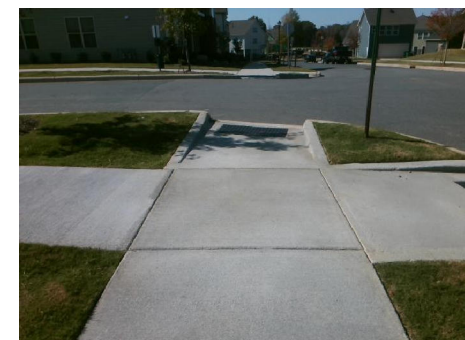
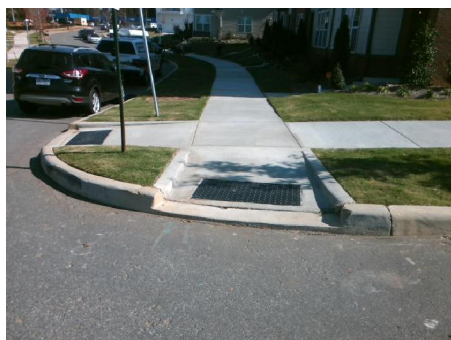
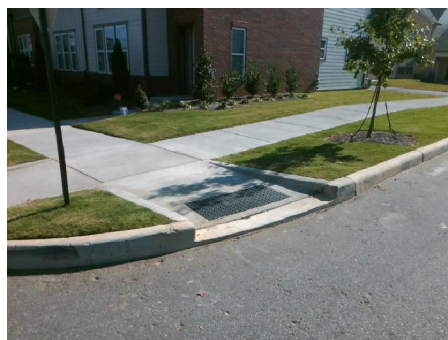
**Not Found, R304.5.3**

Compliance	Description	Data	Compliance	Description	Data
N/A	Ramp Length (in)	82.0	Yes	BlendTrans Slope (%)	1.9
Yes	Ramp Width (in)	67.0	No	BlendTrans XSlope (%)	3.0
N/A	Flare Type LT	N/A	N/A	Flare Type RT	N/A
N/A	Flare Slope LT (%)	N/A	N/A	Flare Slope RT (%)	N/A
N/A	Flare Traversable LT?	N/A	N/A	Flare Traversable RT?	N/A
N/A	Landing Length (in)	N/A	N/A	DWS Provided?	N/A
N/A	Landing Width (in)	N/A	N/A	DWS Contrast?	N/A
N/A	Landing Slope (%)	N/A	N/A	DWS Length (in)	N/A
N/A	Landing X Slope (%)	N/A	N/A	DWS Full Width?	N/A
N/A	Landing Curb? (Y/N)	N/A	N/A	DWS Offset (in)	N/A
N/A	Shared Landing?	N/A			
N/A	Gutter Ponding?	N/A	N/A	Gutter Slope (%)	N/A
N/A	Gutter Lip Ht (in)	2.0	N/A	Gutter X Slope (%)	N/A
N/A	Painted X Walk1?	No	N/A	Painted X Walk2?	N/A
	X Walk 1 Direction	To W		X Walk 2 Direction	N/A
	X Walk 1 Width (in)	N/A		X Walk 2 Width (in)	N/A
	X Walk 1 Slope (%)	3.5		X Walk 2 Slope (%)	N/A
	X Walk 1 X Slope (%)	2.1		X Walk 2 X Slope (%)	N/A

N/A	Ramp inside XWalk1?	N/A	N/A	Ramp inside XWalk2?	N/A
	Road Slope (%)	2.1		Clear Space?	N/A
	Road X Slope (%)	3.5	N/A	Clear Space to XWalk (in)	N/A
N/A	Any Obstructions?	N/A	N/A	Storm Grate/Utility Hazard?	N/A
	Obstruction Type			Storm Grate/Utility Type	
		N/A			N/A
			Yes	Surface Condition? (G/P)	Good
			No	Curb Slope (%)	6.6

**Remove & Replace Curb Ramp With Two New Directional Ramps or Equivalent.**
