# Access Compliance Report

## Public Rights-of-Way

### (Curb Ramps)

| Intersection ID: 48499 | Main Street: CASTLECOVE_RD | Cross Street: MELFORT_WY | Location: SW |

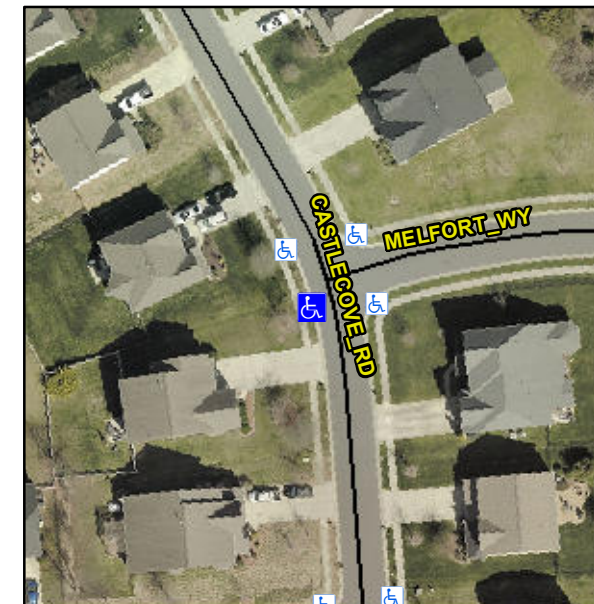
**Not Found, R304.2.1, R304.5.3**

| Compliance | Description | Data | Compliance | Description | Data |
|---|---|---|---|---|---|
| No | Landing Length (in) | 47.0 | Yes | DWS Provided? | Yes |
| No | Landing X Slope (%) | 4.3 | Yes | DWS Full Width? | Yes |

**Remove & Replace Entire Ramp.**

Total Cost: \$ 1850.00
