# Access Compliance Report

## Public Rights-of-Way

### (Curb Ramps)

Intersection ID: 23690	Main Street: CRESSIDA_DR	Cross Street: E WESTINGHOUSE BV	Location: SE
ADA ID: E1FF123F2236	Ramp Type: PerpDiag	Initial Pass/Fail: Fail	Overall Compliance: No
Severity Score: 21.25			
Codes/Mitigation Info/Possible Solution		Field Measurements/Component Compliance

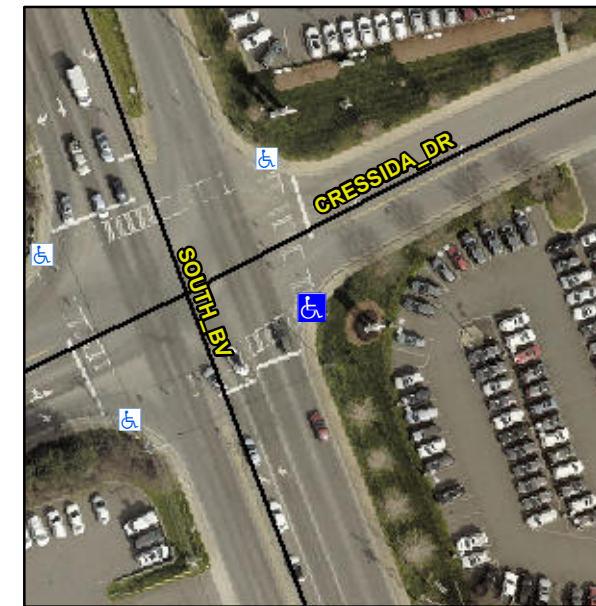
**Not Found, R304.5.1, R304.2.2**

Compliance	Description	Data	Compliance	Description	Data
N/A	Ramp Length (in)	61.0	No	Ramp Slope (%)	9.0
No	Ramp Width (in)	37.0	Yes	Ramp XSlope (%)	0.9
N/A	Flare Type LT	N/A	N/A	Flare Type RT	N/A
N/A	Flare Slope LT (%)	N/A	N/A	Flare Slope RT (%)	N/A
N/A	Flare Traversable LT?	N/A	N/A	Flare Traversable RT?	N/A
N/A	Landing Length (in)	N/A	N/A	DWS Provided?	N/A
N/A	Landing Width (in)	N/A	N/A	DWS Contrast?	N/A
N/A	Landing Slope (%)	N/A	N/A	DWS Length (in)	N/A
N/A	Landing X Slope (%)	N/A	N/A	DWS Full Width?	N/A
N/A	Landing Curb? (Y/N)	N/A	N/A	DWS Offset (in)	N/A
N/A	Shared Landing?	N/A			
N/A	Gutter Ponding?	N/A	N/A	Gutter Slope (%)	N/A
N/A	Gutter Lip Ht (in)	N/A	N/A	Gutter X Slope (%)	N/A
N/A	Painted X Walk1?	Yes	N/A	Painted X Walk2?	Yes
	X Walk 1 Direction	To N		X Walk 2 Direction	To SW
N/A	X Walk 1 Width (in)	116.0	N/A	X Walk 2 Width (in)	110.0
	X Walk 1 Slope (%)	1.0		X Walk 2 Slope (%)	3.3
	X Walk 1 X Slope (%)	2.1		X Walk 2 X Slope (%)	0.9

N/A	Ramp inside XWalk1?	Yes	N/A	Ramp inside XWalk2?	Yes
	Road Slope (%)	2.7	N/A	Clear Space?	N/A
	Road X Slope (%)	1.0	N/A	Clear Space to XWalk (in)	N/A
N/A	Any Obstructions?	N/A	N/A	Storm Grate/Utility Hazard?	N/A
	Obstruction Type			Storm Grate/Utility Type	
		N/A			N/A
		Yes		Surface Condition? (G/P)	Good

**Remove & Replace Curb Ramp With Two New Directional Ramps or Equivalent.**
