Access Compliance Report Public Rights-of-Way (Curb Ramps)

Intersection ID: 3973 Main Street: MALLARD CREEK RD Cross Street: W_MALLARD_CREEK_CHURCH_RD Location: N ADA ID: E207C527B255 Ramp Type: Perp Initial Pass/Fail: Fail **Overall Compliance: No Severity Score:** 35

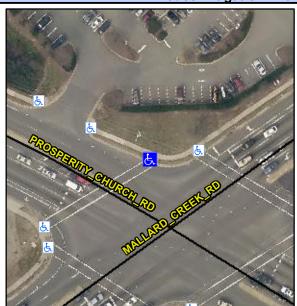
Field Measurements/Component Compliance					
Compliance Description Data		Data	Comp	liance Description	Data
N/A	Ramp Length (in)	53.5	No	Ramp Slope (%)	20.0
No	Ramp Width (in)	47.0	Yes	Ramp XSlope (%)	2.2
N/A	Flare Type LT	N/A	N/A	Flare Type RT	N/A
N/A	Flare Slope LT (%)	N/A	N/A	Flare Slope RT (%)	N/A
N/A	Flare Traversable LT?	N/A	N/A	Flare Traversable RT?	N/A
N/A	Landing Length (in)	N/A	N/A	DWS Provided?	N/A
N/A	Landing Width (in)	N/A	N/A	DWS Contrast?	N/A
N/A	Landing Slope (%)	N/A	N/A	DWS Length (in)	N/A
N/A	Landing X Slope (%)	N/A	N/A	DWS Full Width?	N/A
N/A	Landing Curb? (Y/N)	N/A	N/A	DWS Offset (in)	N/A
N/A	Shared Landing?	N/A			
N/A	Gutter Ponding?	N/A	N/A	Gutter Slope (%)	N/A
N/A	Gutter Lip Ht (in)	N/A	N/A	Gutter X Slope (%)	N/A
N/A	Painted X Walk1?	Yes	N/A	Painted X Walk2?	N/A
	X Walk 1 Direction	To SW		X Walk 2 Direction	N/A
N/A	X Walk 1 Width (in)	105.0	N/A	X Walk 2 Width (in)	N/A
	X Walk 1 Slope (%)	0.4		X Walk 2 Slope (%)	N/A

X Walk 1 X Slope (%)	2.2		X Walk 2 X Slope (%)	N/A
N/A	Ramp inside XWalk1?	Yes	N/A	Ramp inside XWalk2?	N/A
	Road Slope (%)	N/A	N/A	Clear Space?	N/A
	Road X Slope (%)	N/A	N/A	Clear Space to XWalk (in)	N/A
N/A	Any Obstructions?	N/A	N/A	Storm Grate/Utility Hazard?	N/A
	Obstruction Type			Storm Grate/Utility Type	
		N/A			N/A
			Yes	Surface Condition? (G/P)	Good
92/1007

PROSPERITY CHURCH RD Street 1 Name Stop Condition-Street 2 Signal Street 2 Name N/A Stop Condition-Street 1 N/A Possible Solutions: Remove & Replace Entire Ramp. Surveyor Notes: N/A PROW/ADA: R304.5.1, R304.2.2
